City of Chanhassen Facilities Planning Study

Council Workshop Presentation
10 January 2022

SNOW
KREILICH
ARCHITECTS

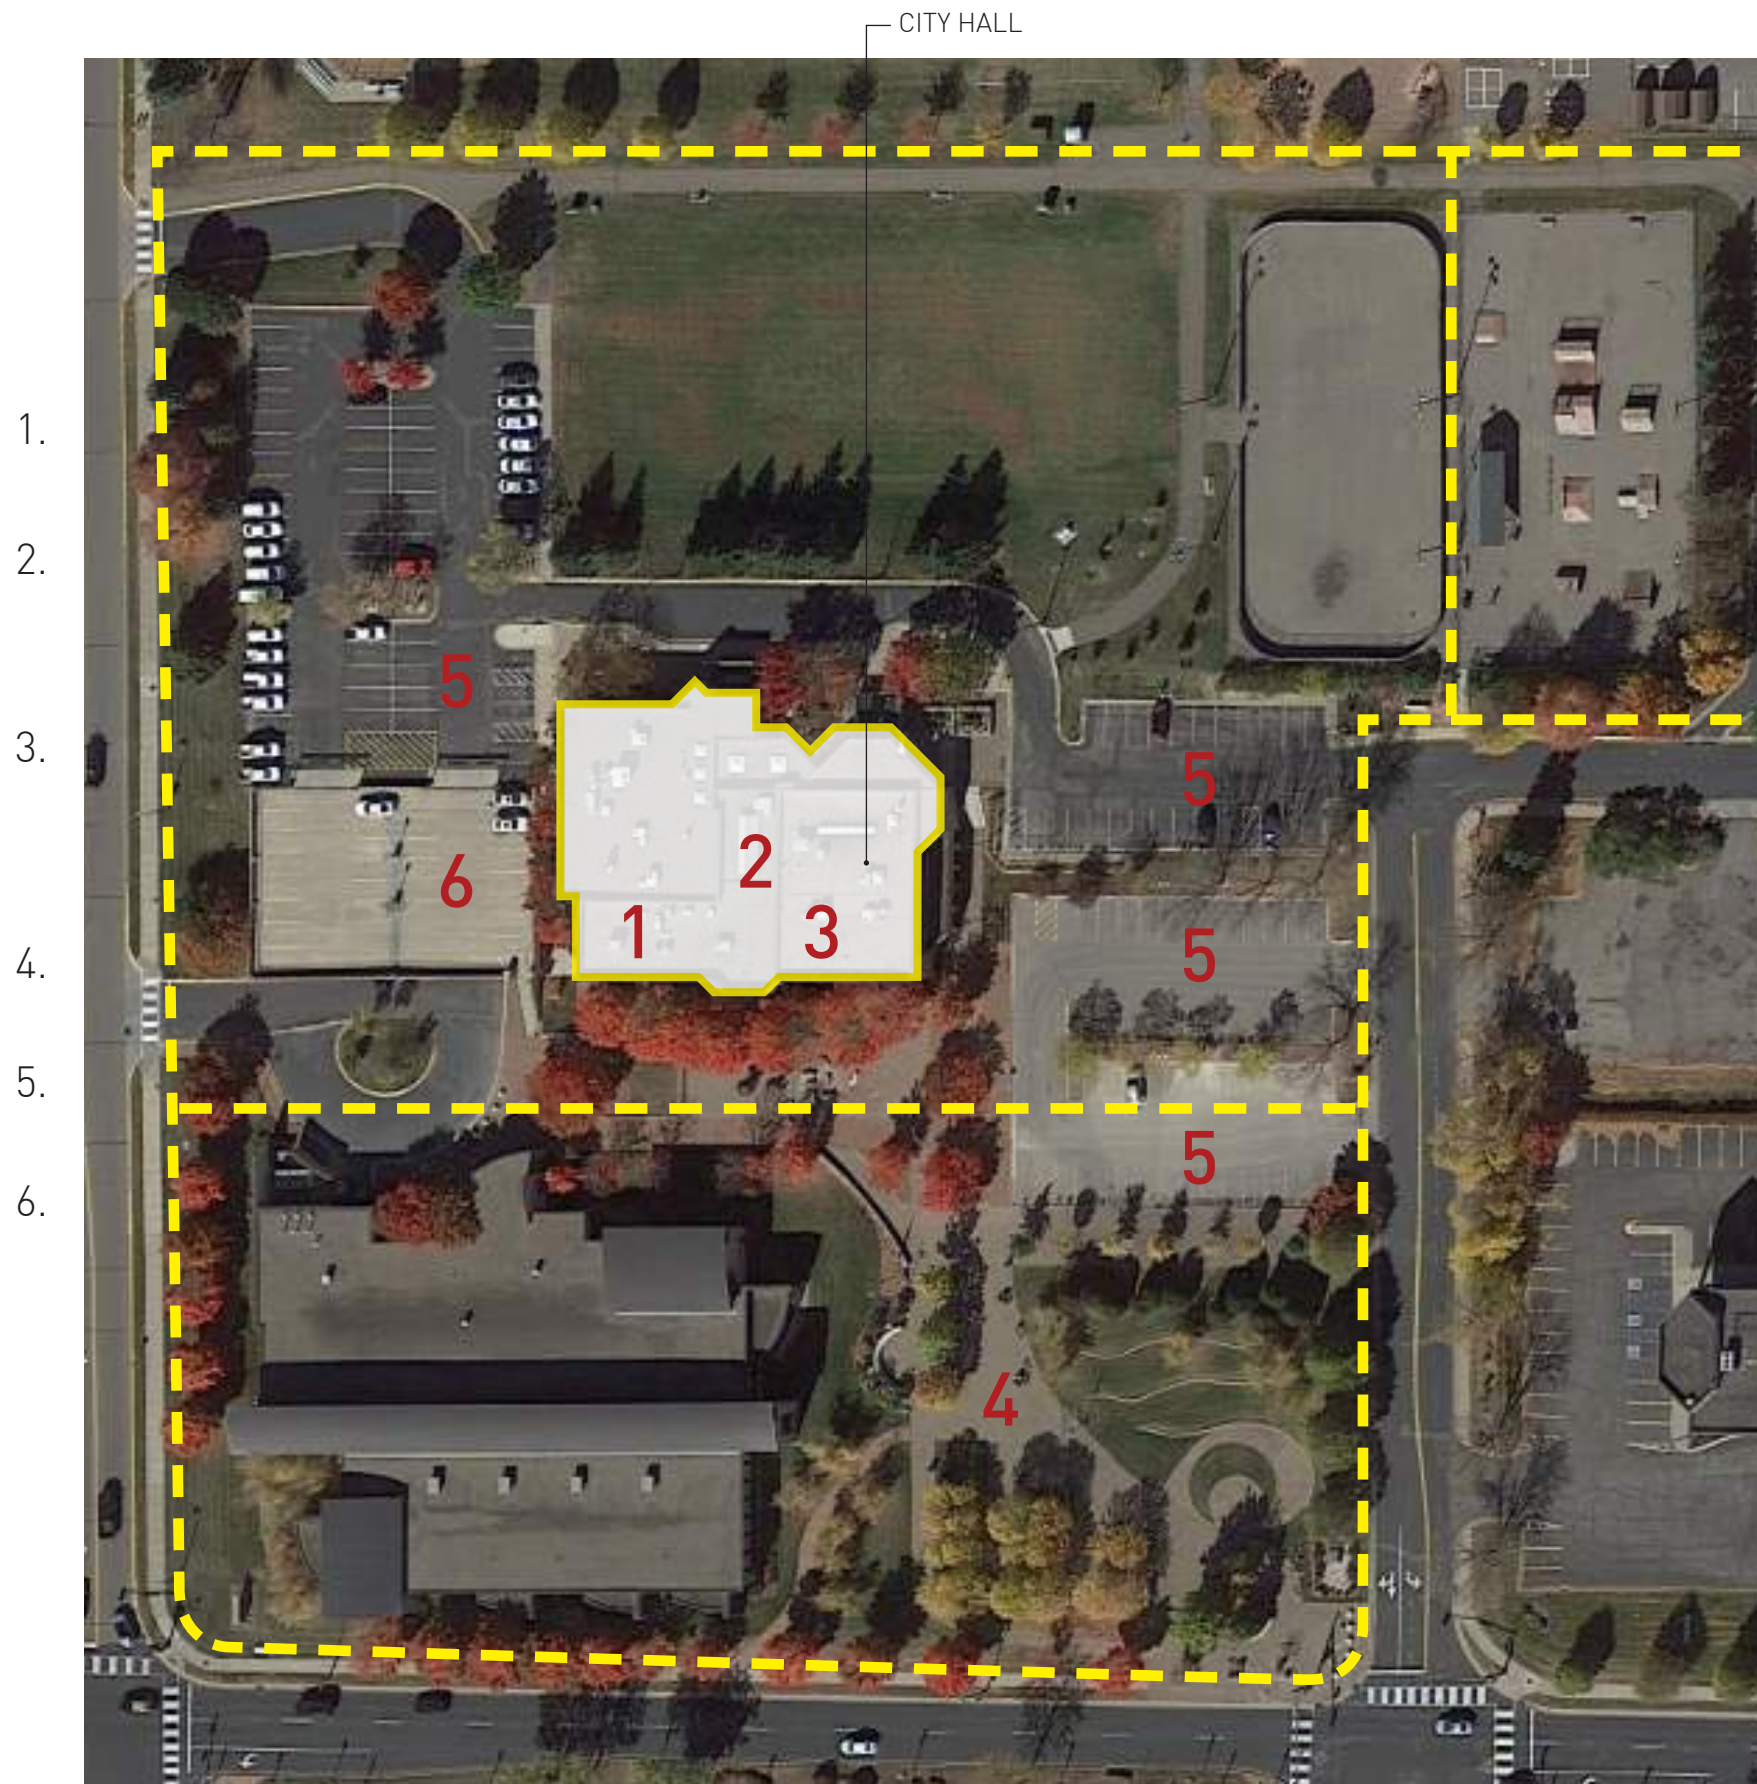
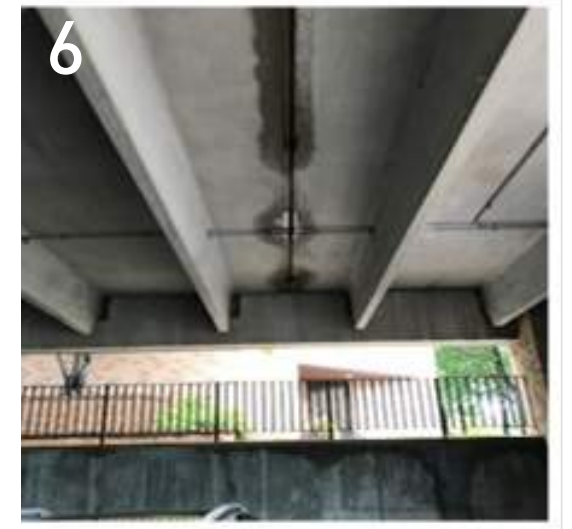
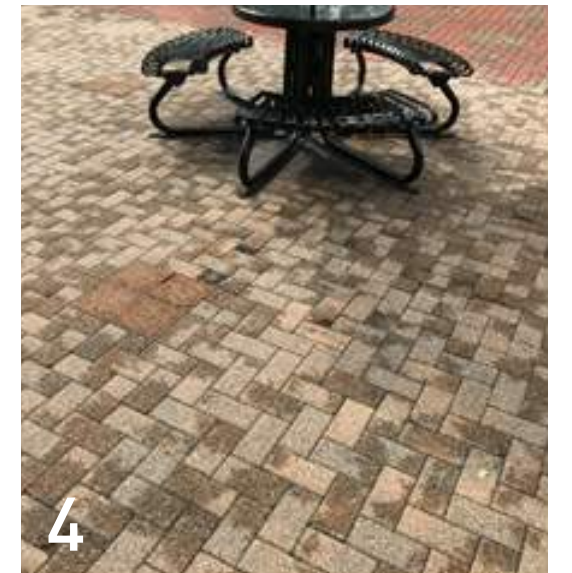
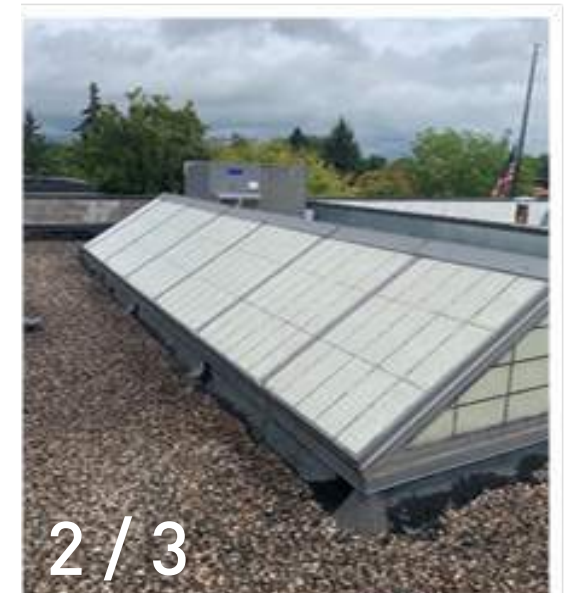
- Exterior Enclosure

- » Exterior windows need to be replaced
- » Kalwall skylights need to be replaced

- Roof

- » Roof is scheduled to be replaced in 2023

- Site Work

- » Replace stone pavers around the facility.
- » Mill and overlay of the parking lots
- » Review joints and sealant in parking ramp (leaking)

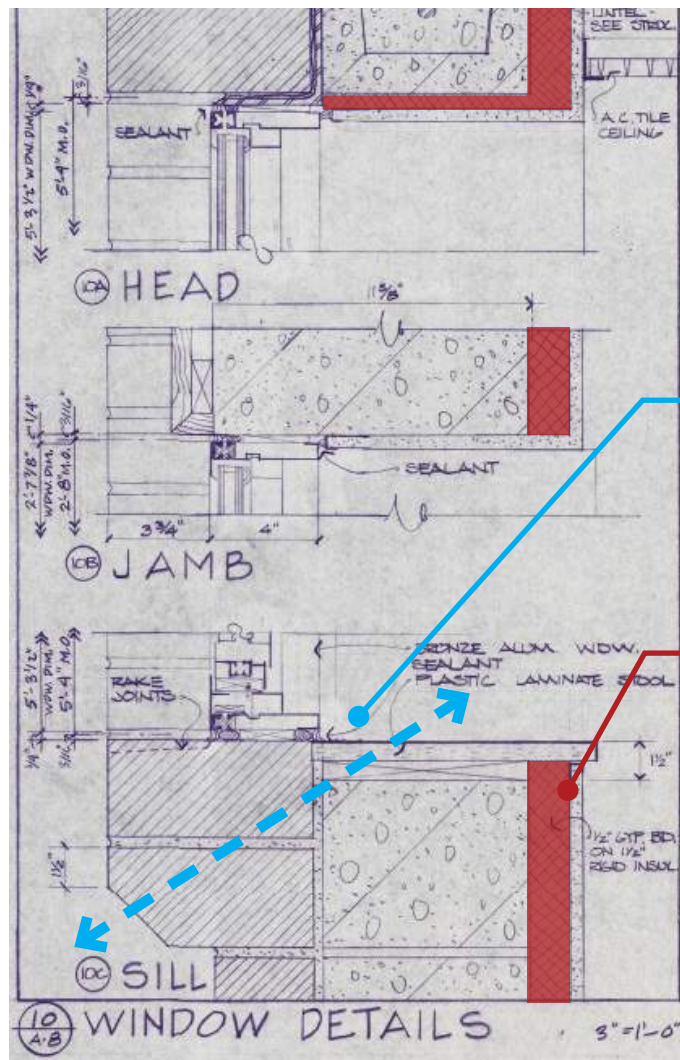
1980

air leakage / high condensation & frost potential

Perlite Board
(R2.7 / 1")

R= 4.05

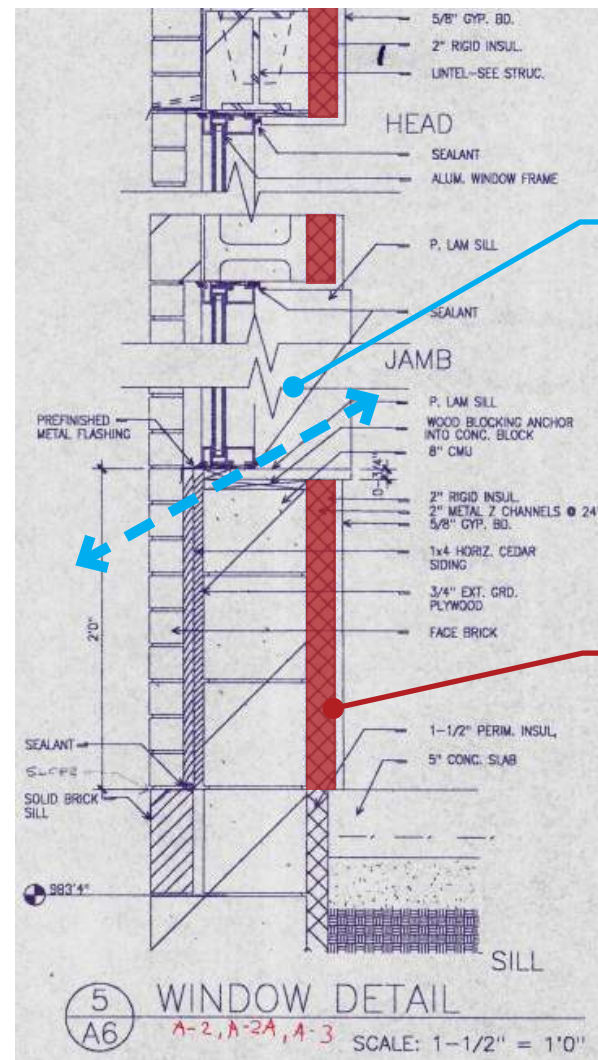
1988

air leakage / high condensation & frost potential

Rigid Foam
(R3-4 / 1")

R= 4.5 - 6

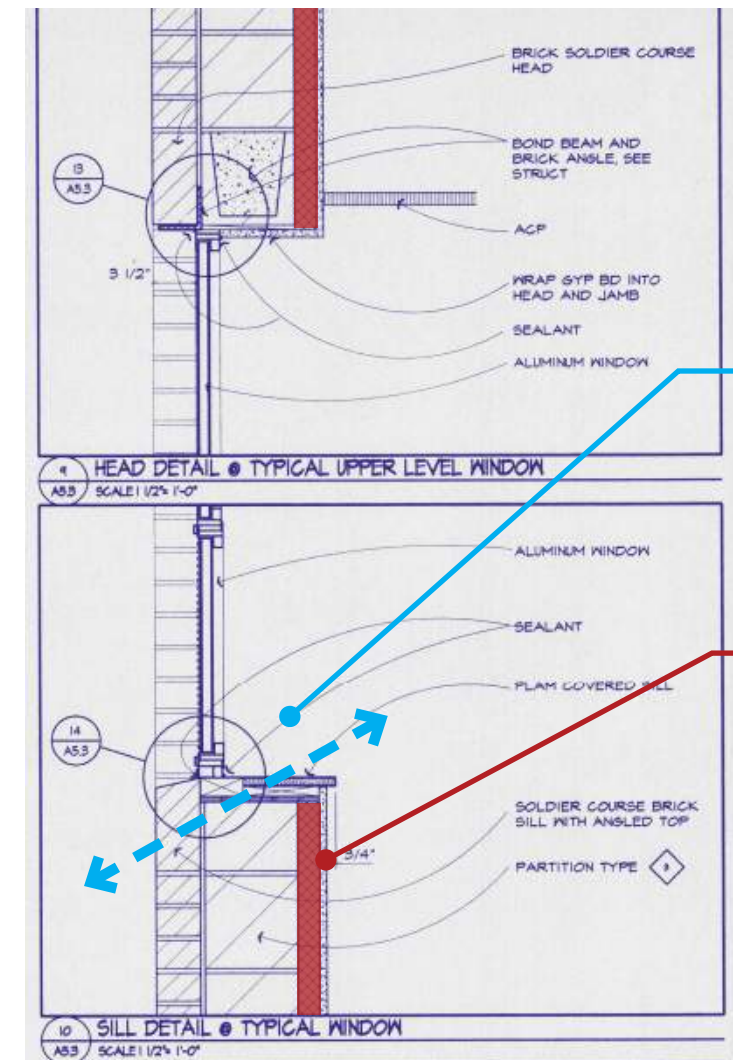
1996

air leakage / high condensation & frost potential

Rigid Foam
(R4-5 / 1")

R= 8 - 10

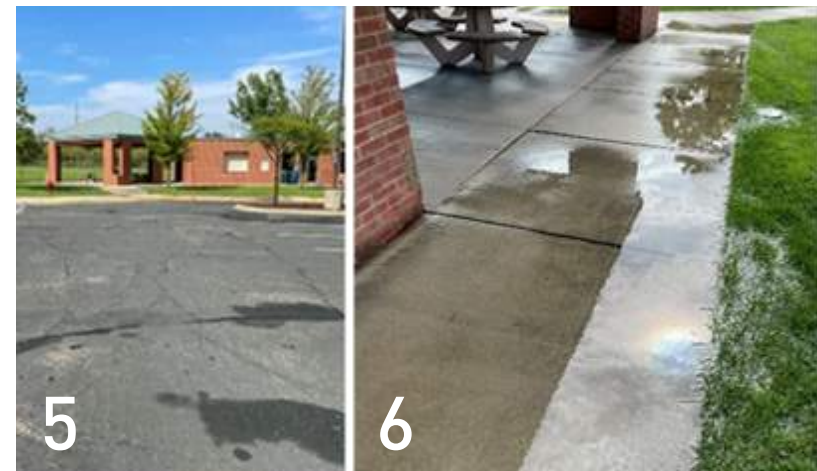
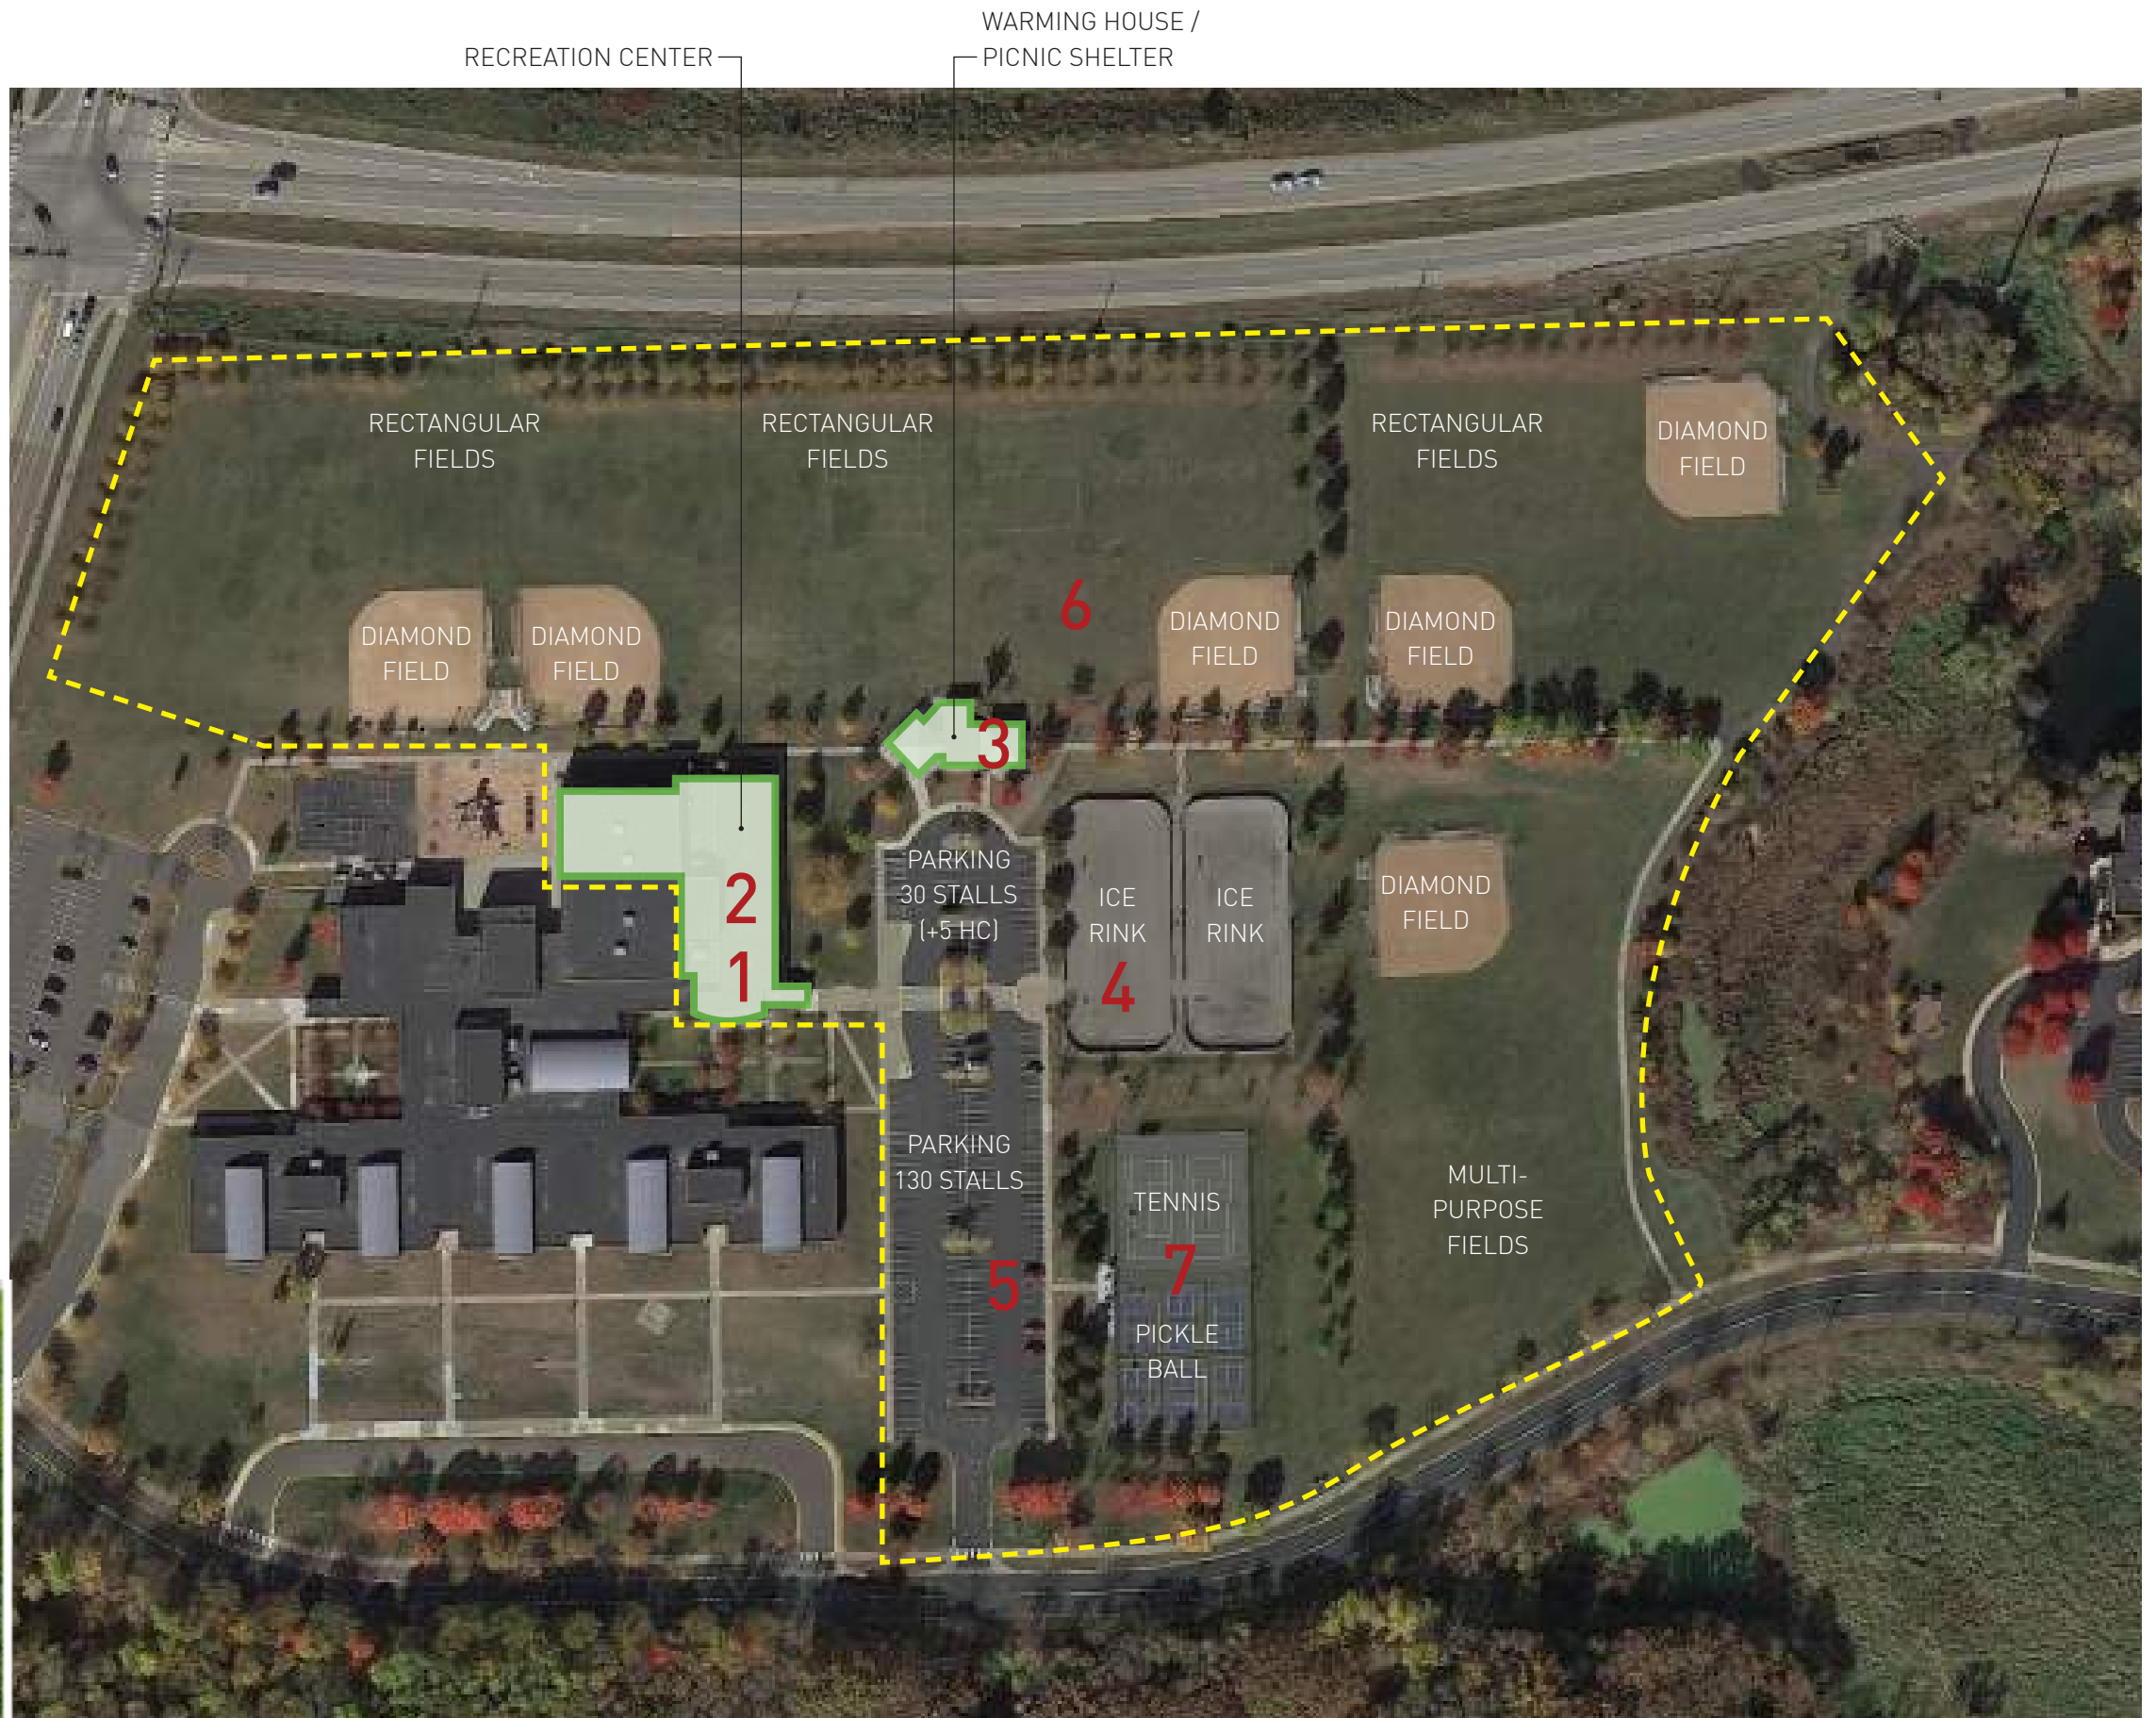
- Exterior Enclosure

- » Replace handicap doors in front entrance
- » Replacement of windows

- Roof

- » Replace roof for the warming house (ballasted portion only)

- Site Work

- » Update skating rink lighting
- » Mill and overlay of parking lot
- » Assess the drainage issue onsite
- » Repair of tennis and pickle ball courts

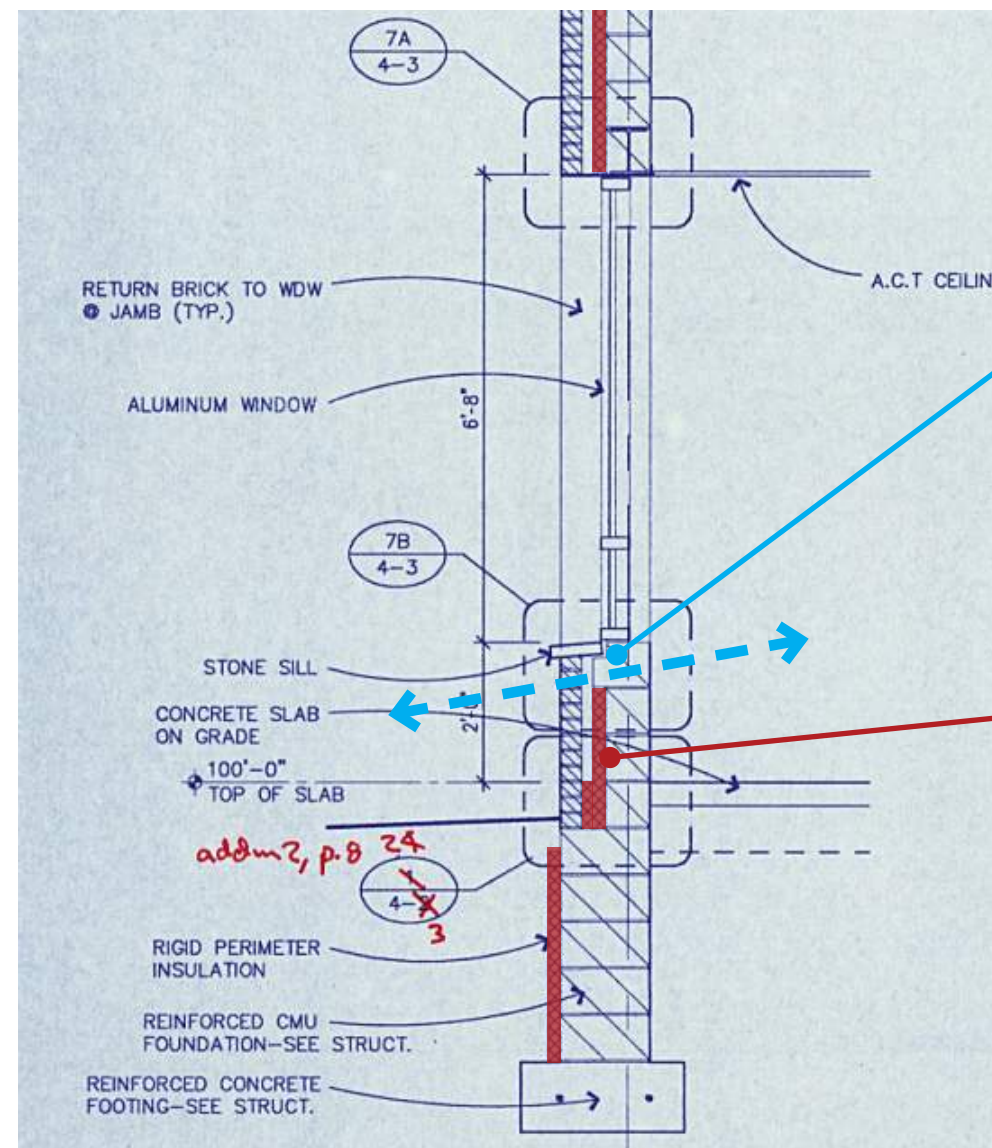
1994

air leakage / high condensation & frost potential

Extruded Polystyrene Board

R5 / 1")

R= 10

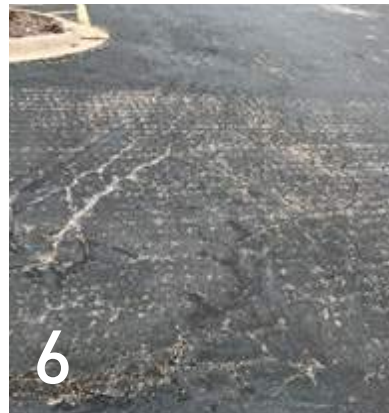
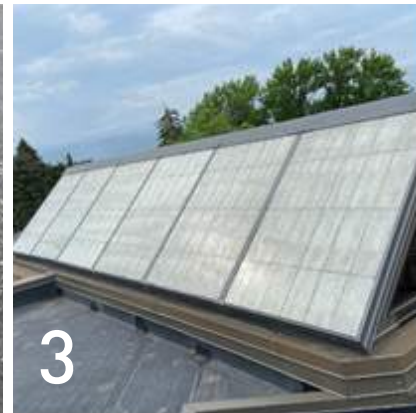
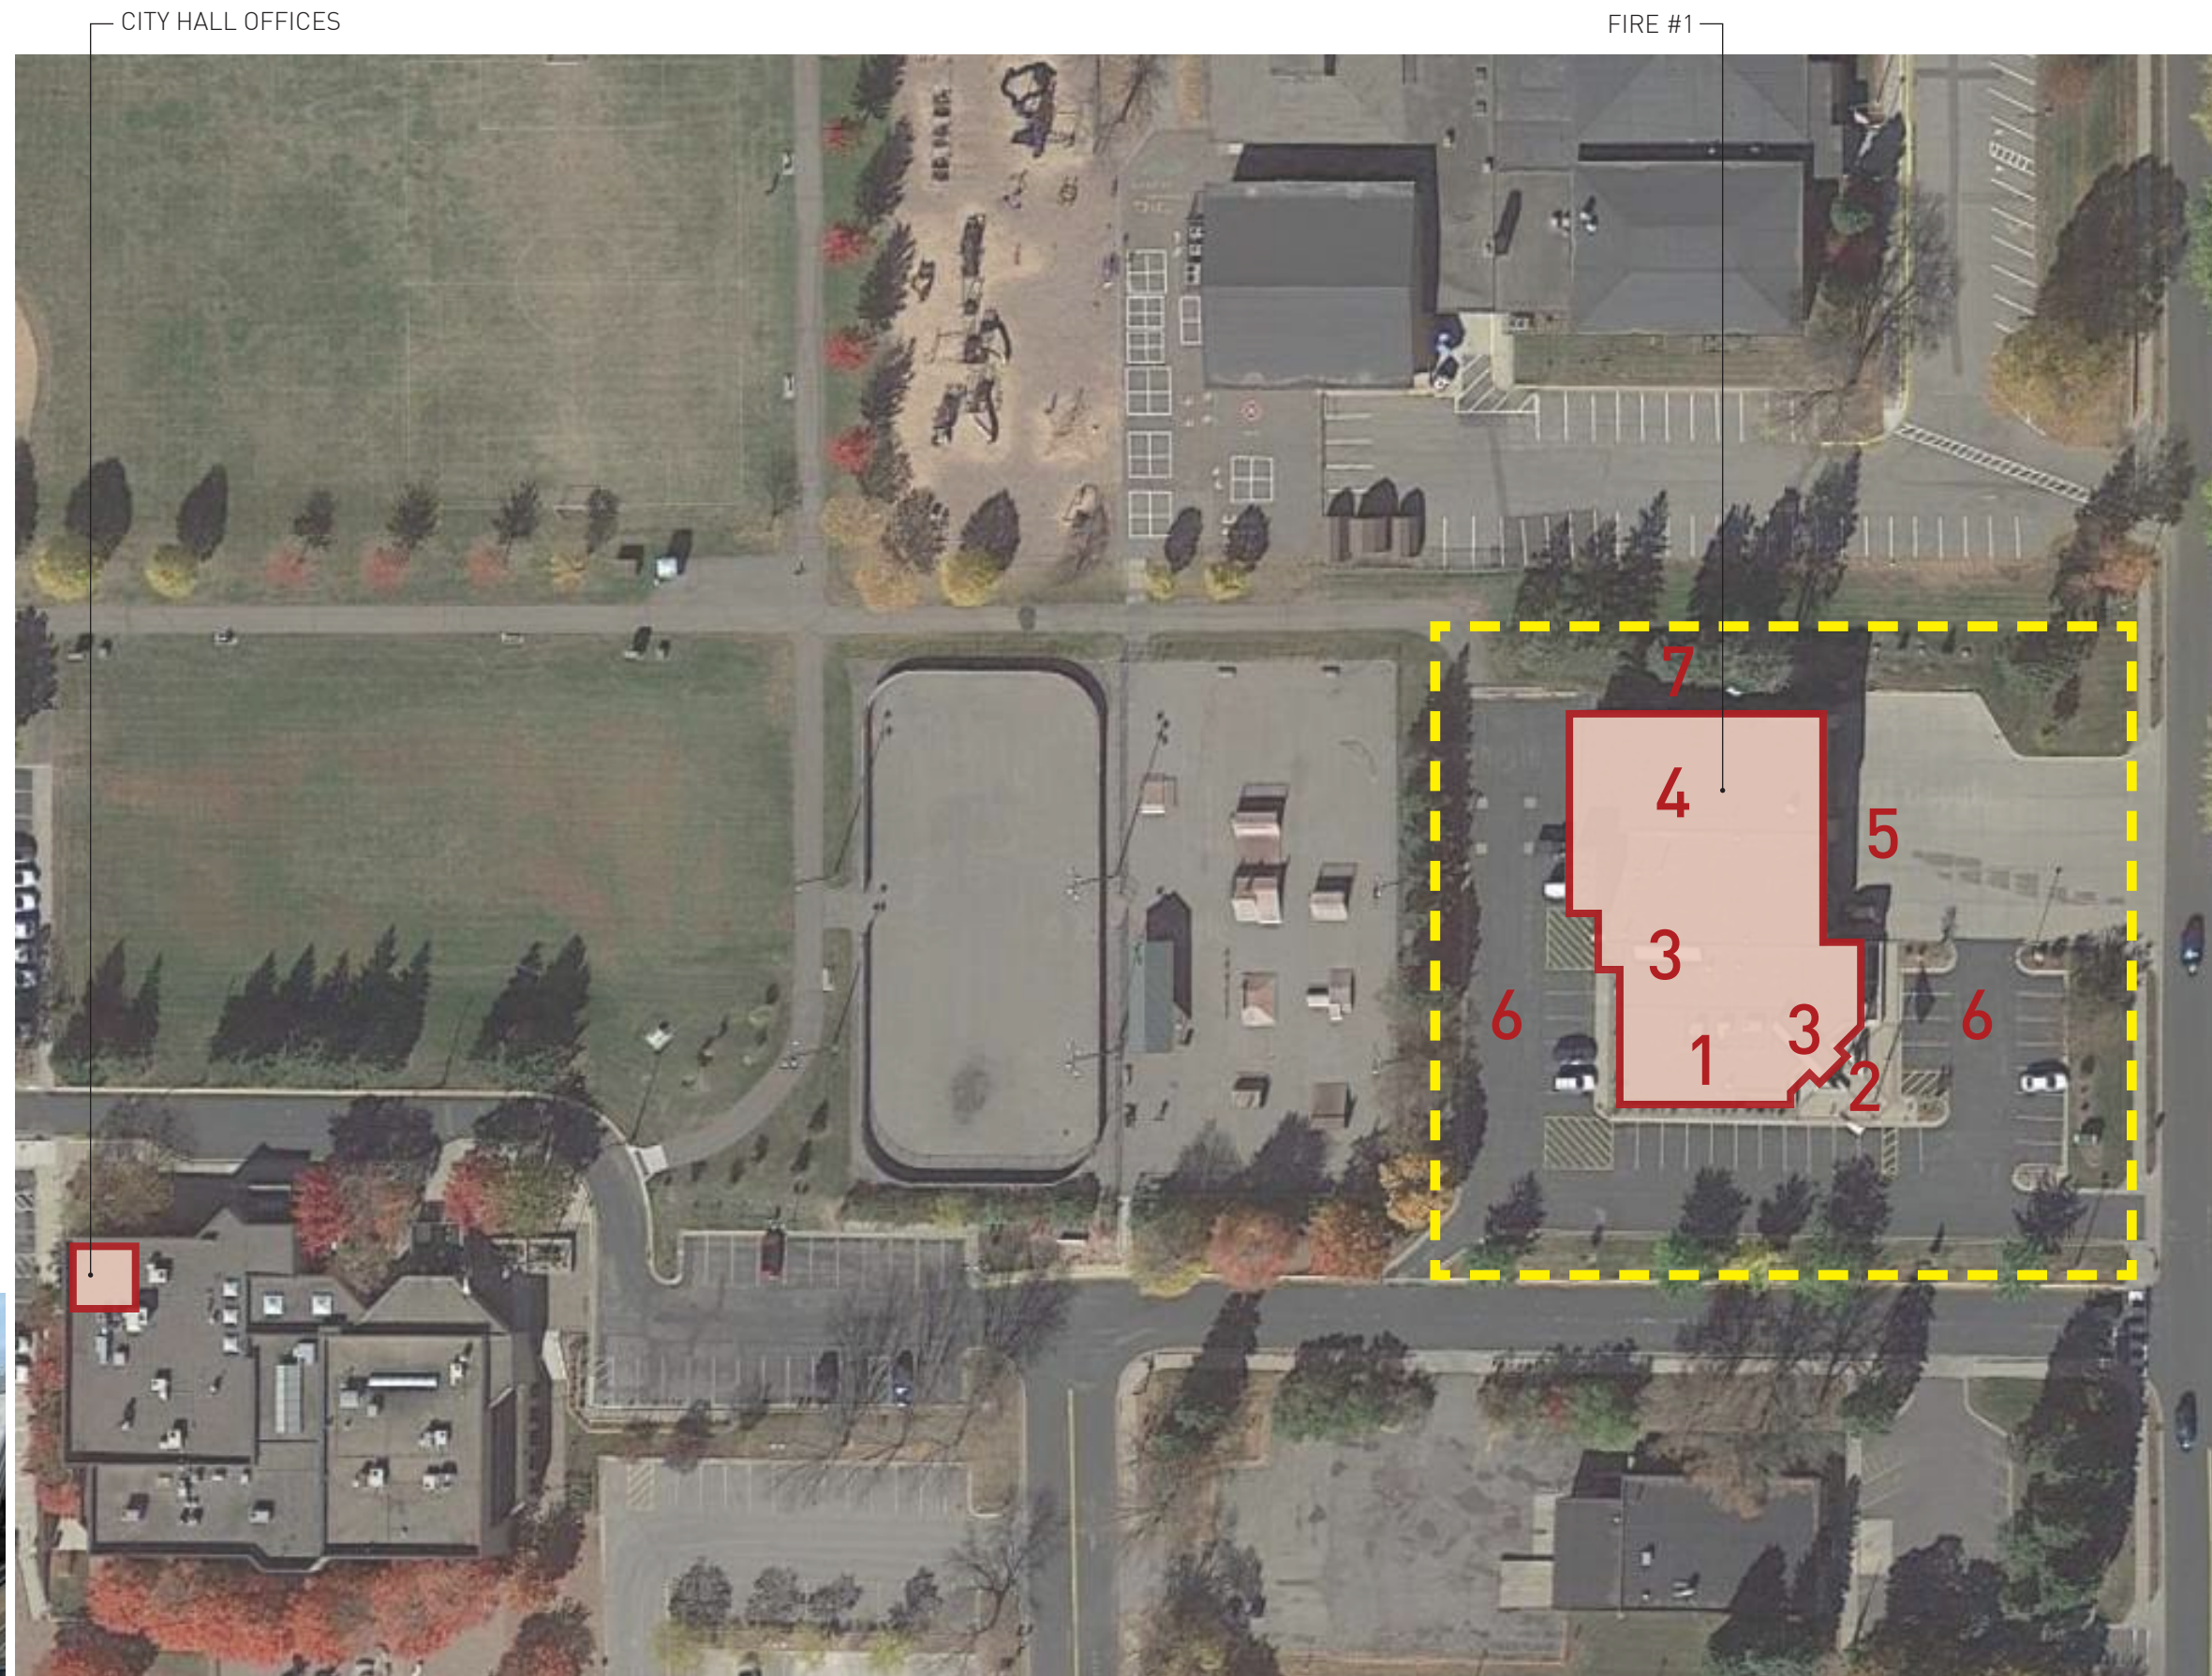
- Exterior Enclosure

- » Clean and seal of exterior brickwork 1.
- » Replace main entry doors and aluminum windows 2.
- » Kalwall skylight replacement 3.

- Roof

- » Roof has been replaced recently. Next replacement later in the plan 4.

- Site Work

- » Replace concrete drive for trucks to enter and exit the station 5.
- » Mill and overlay of parking lot 6.
- » Regrade north side of the building (Water pooling up) 7.

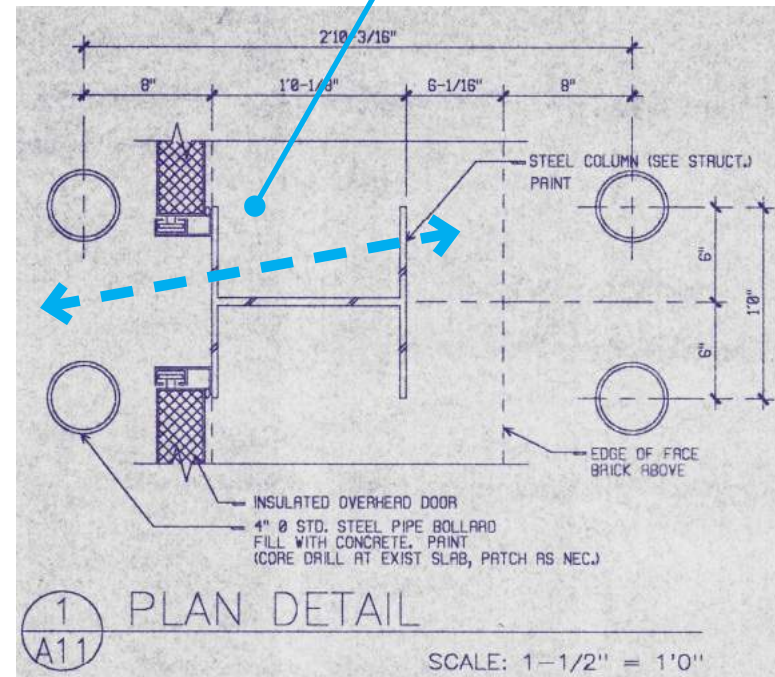
1988

uninsulated steel column - exposed to weather and subject to frost / ice build-up

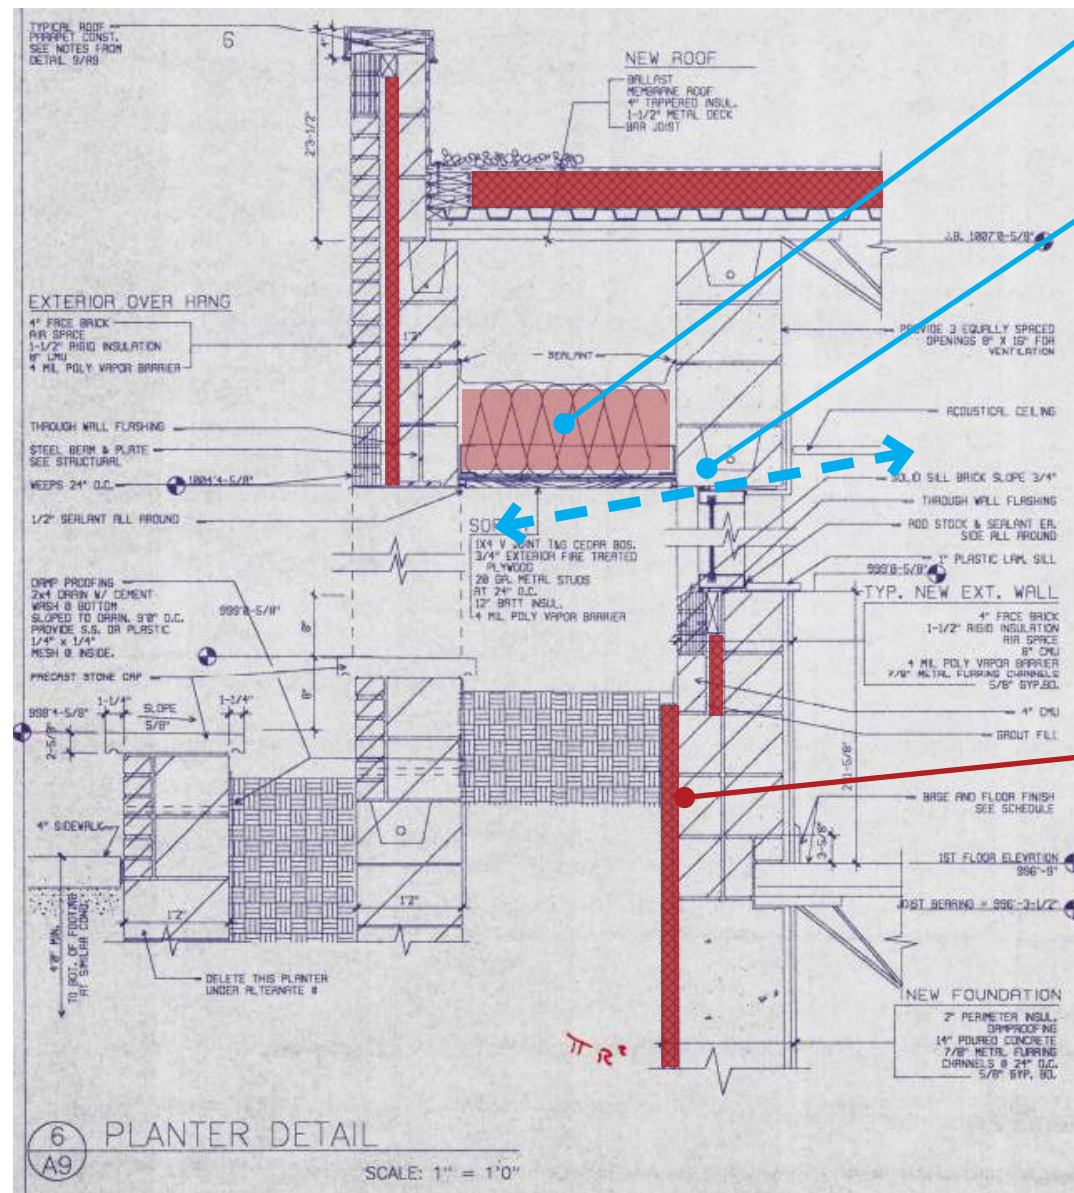
1988

air leakage at batt insulation / high condensation & mold potential
air leakage / high condensation & frost potential

Extruded Polystyrene Board
R5 / 1")
R= 10

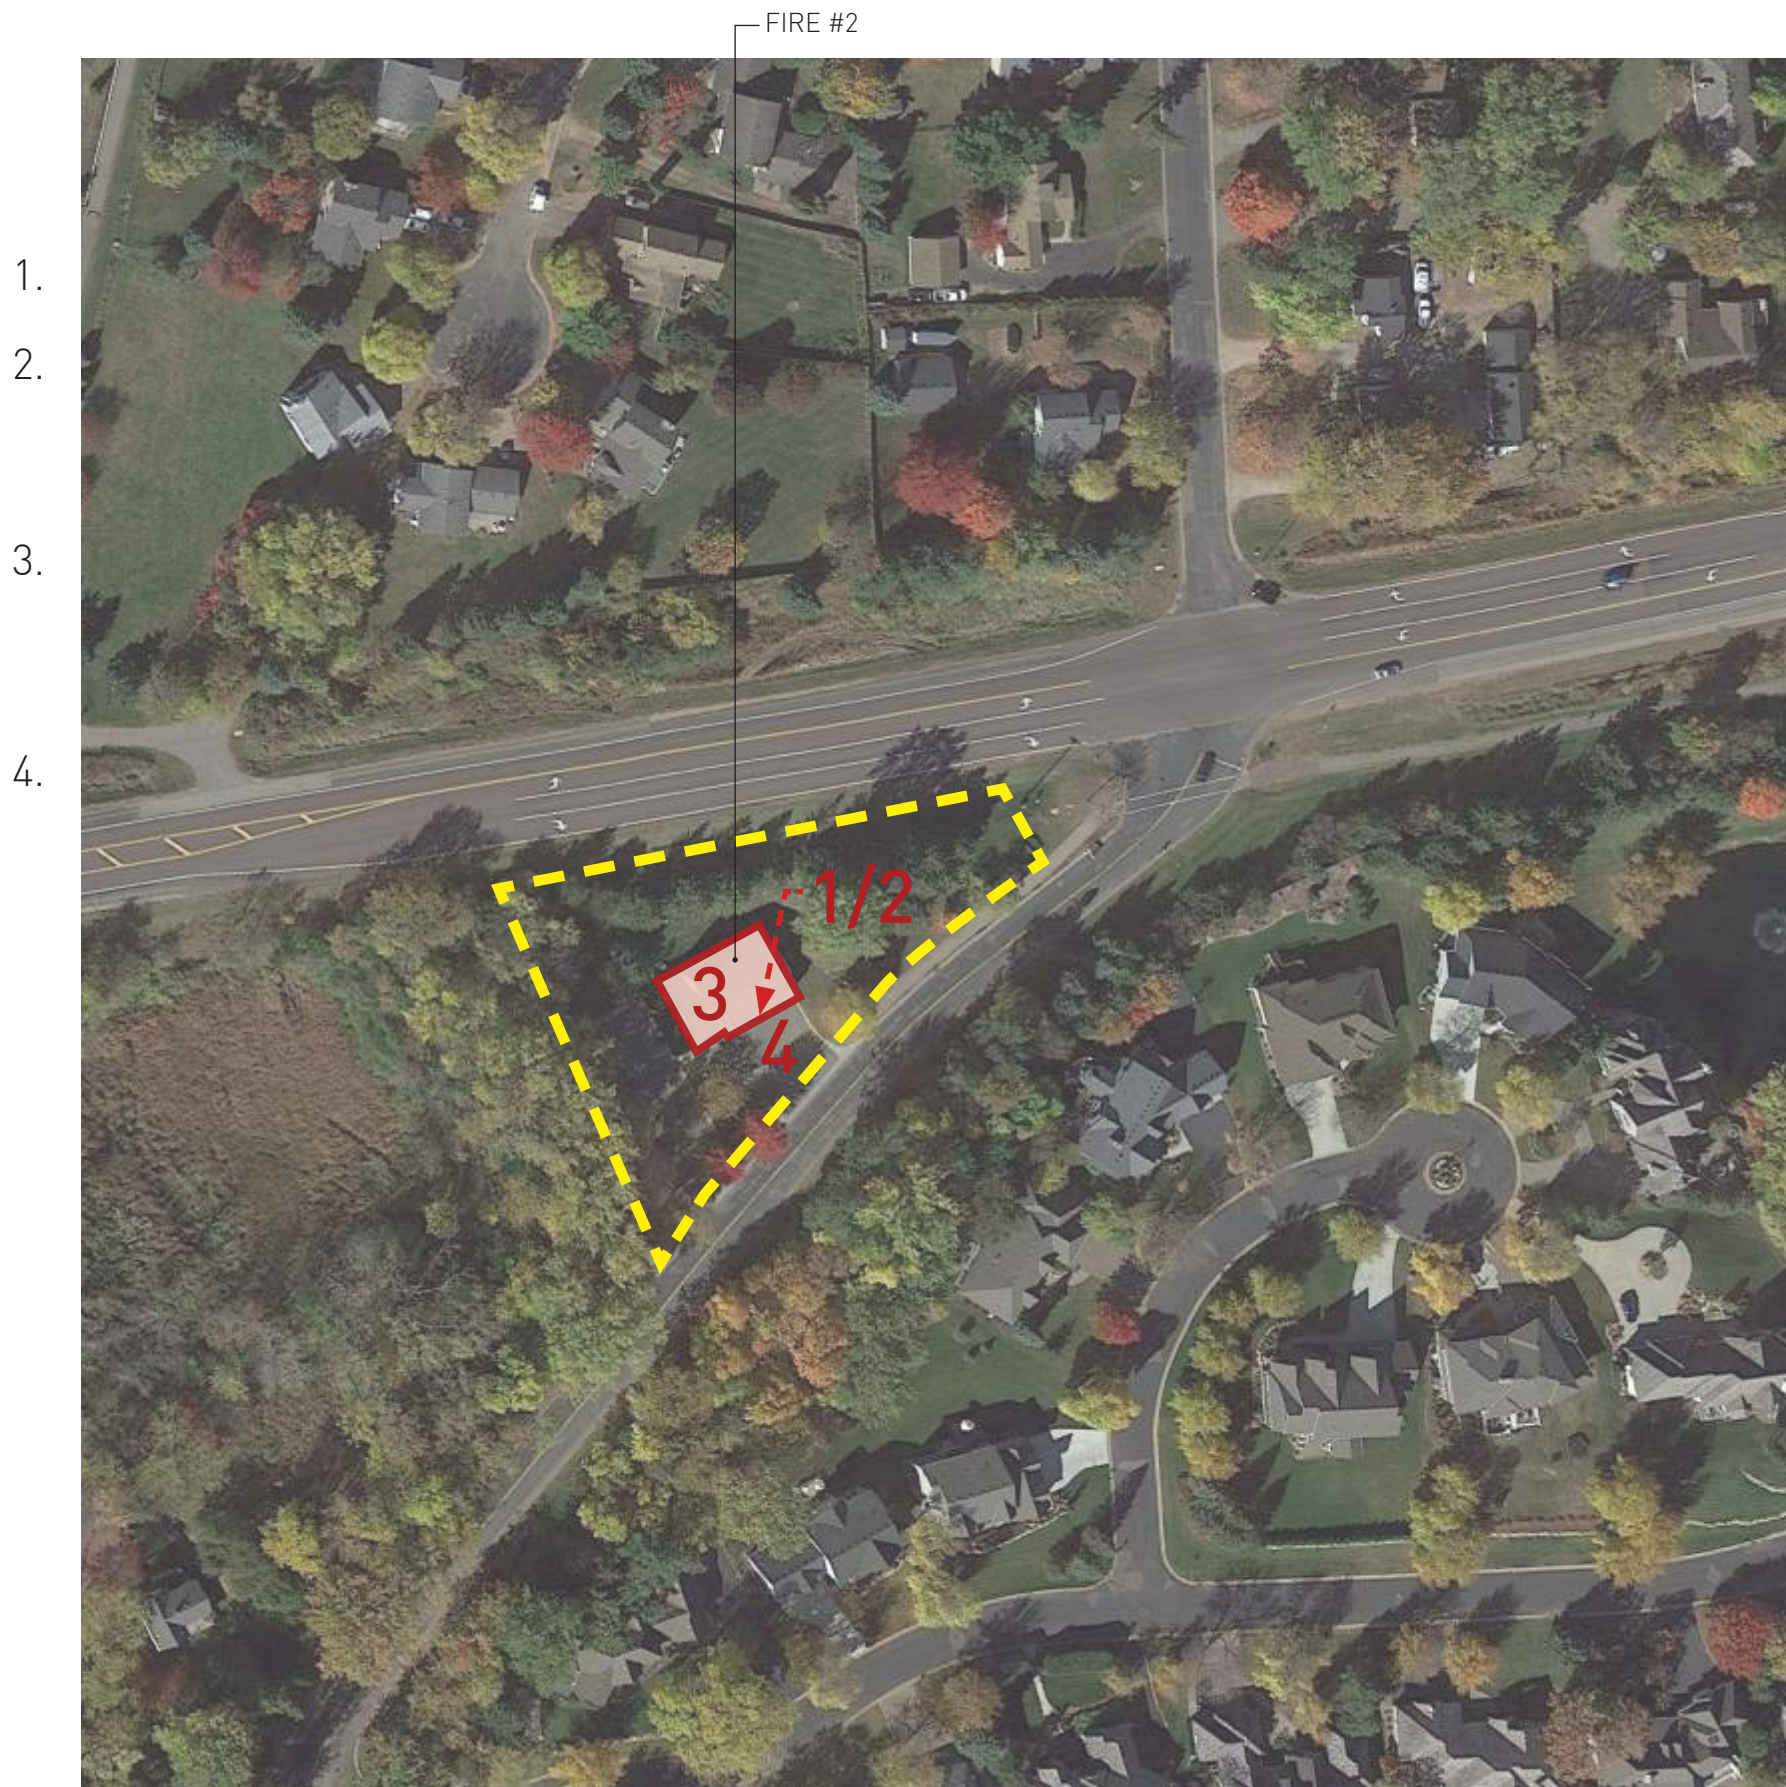
- Exterior Enclosure

- » Repair frame of garage door
- » Replace exterior door from bay

- Roof

- » Asphalt roof in good shape

- Site Work

- » Sealcoat of parking lot
