City of Chanhassen Facilities Planning Study

Council Workshop Presentation
10 January 2022

SNOW
KREILICH
ARCHITECTS

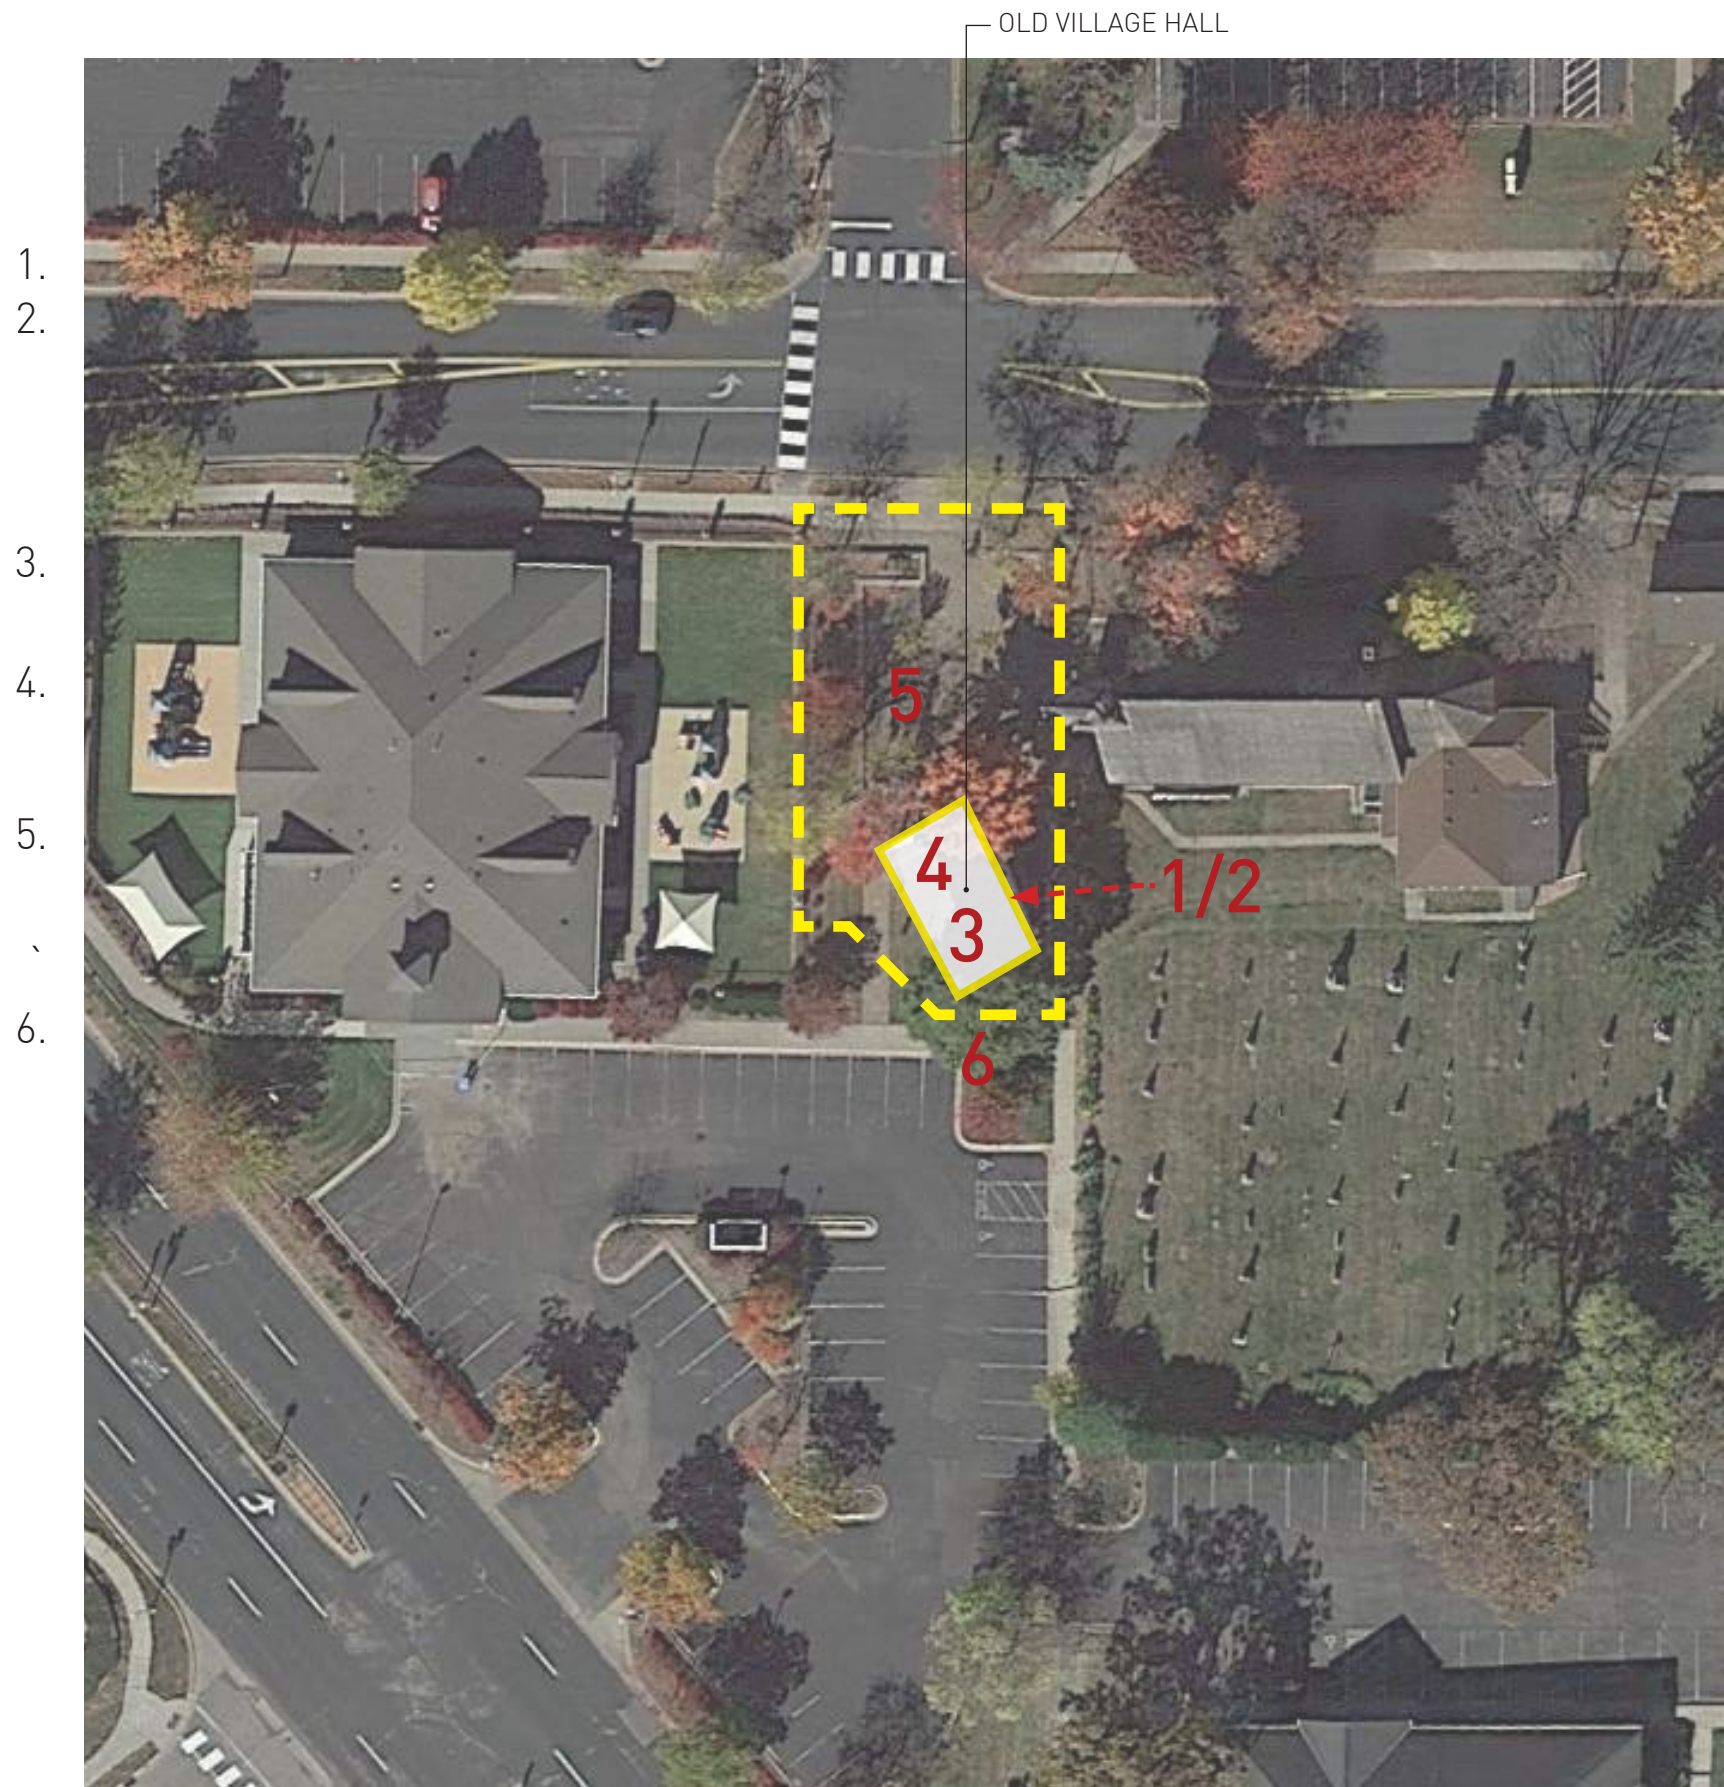
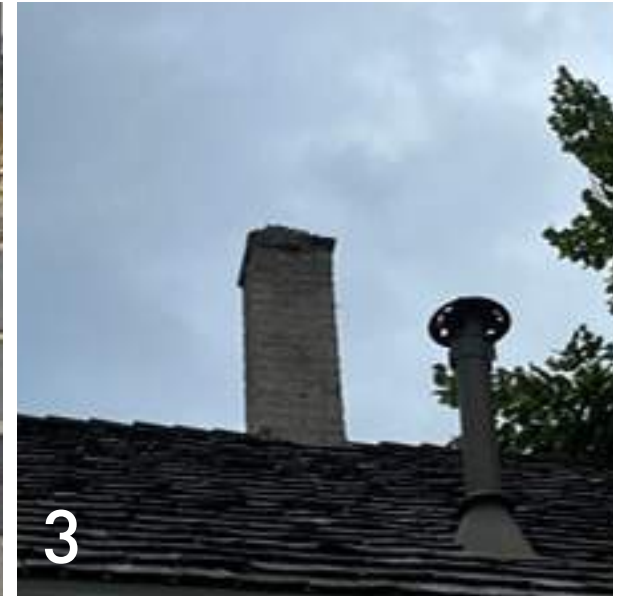
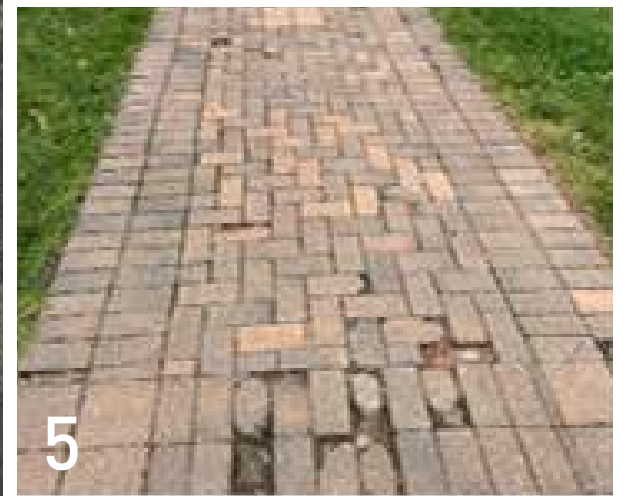
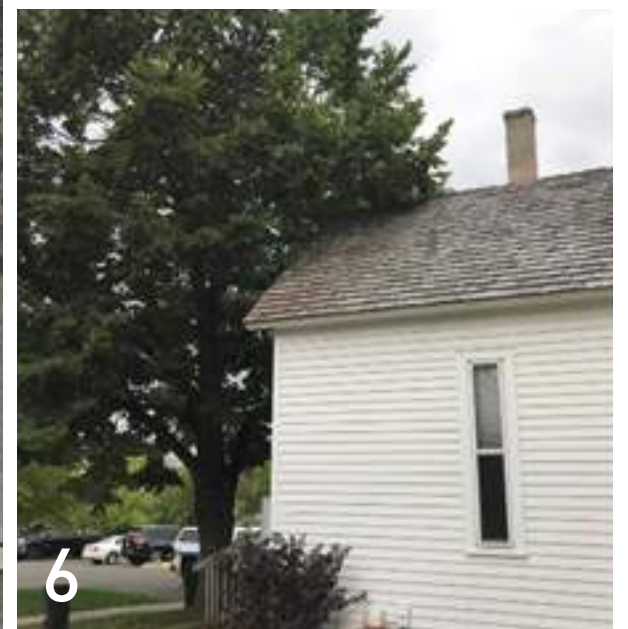
- Exterior Enclosure

- » Replace windows
- » Exterior paint on building is starting to chip

- Roof

- » Chimney is starting to deteriorate
- » Bell tower damaged

- Site Work

- » Many missing bricks in the walkway, repair these areas. (May need to regrade some areas)
- » Trim trees at building
