**Bluff Creek Watershed**

**Total Maximum Daily Load Report:  
Turbidity and Fish Bioassessment Impairments**

**Submitted by:**  
**Minnesota Pollution Control Agency**

**June, 2013**

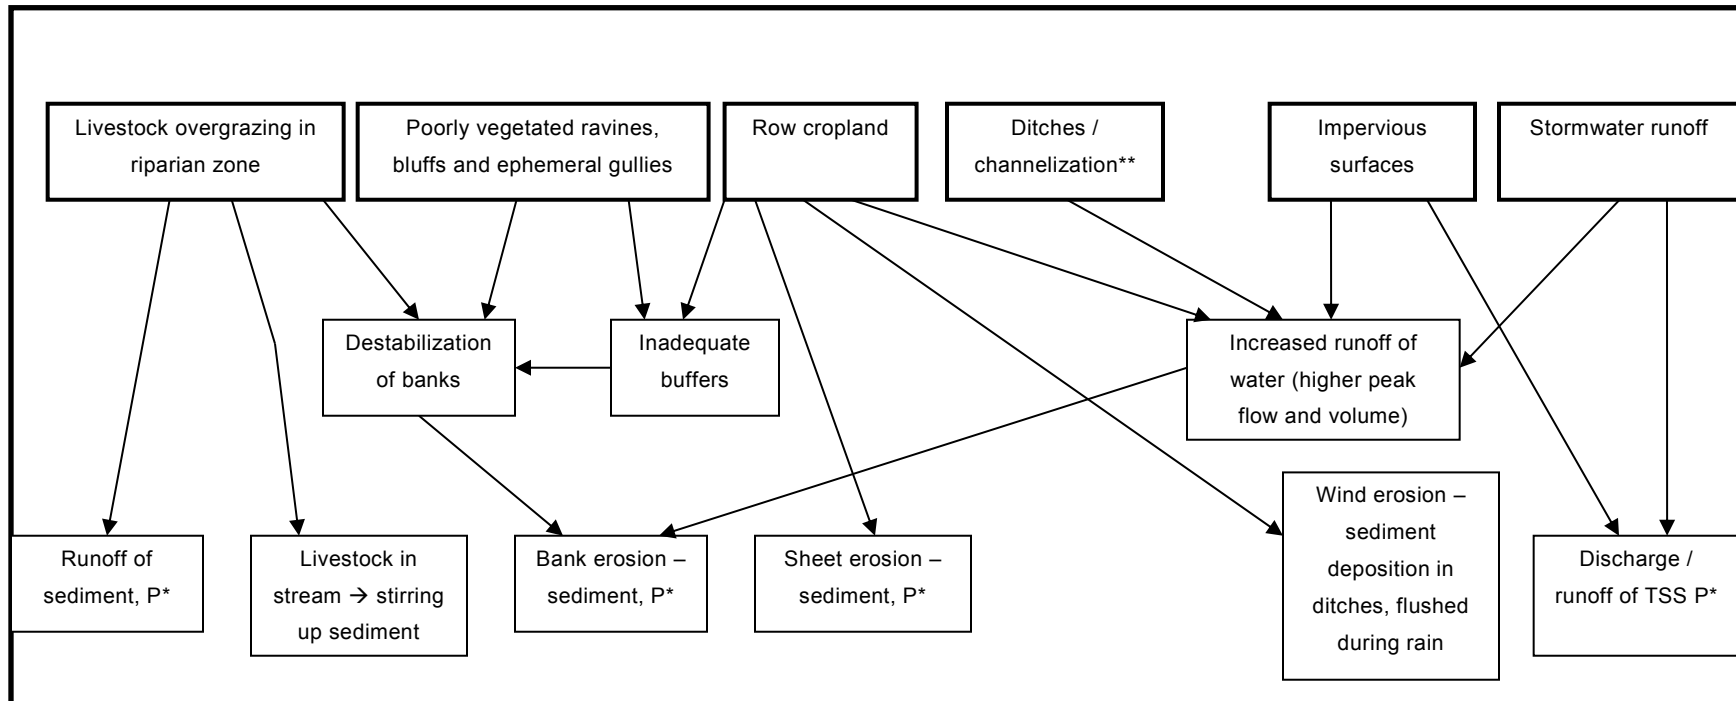
**Figure 3.5 Simplified turbidity conceptual model of candidate sources and potential pathways**

\* Phosphorus (P) can contribute to turbidity through production of algal blooms during lower flow periods or in low-gradient/low-velocity portions of stream.

\*\* Ditches / channelization also can cause sediment delivery via:

- bank erosion as watercourses revert to original meandering
- scour erosion at side-inlets
- steeper gradient can cause headward erosion and downcutting (nickpoints may form; channel erodes nickpoint resulting in upstream scour)
- ditch cleaning / dredging

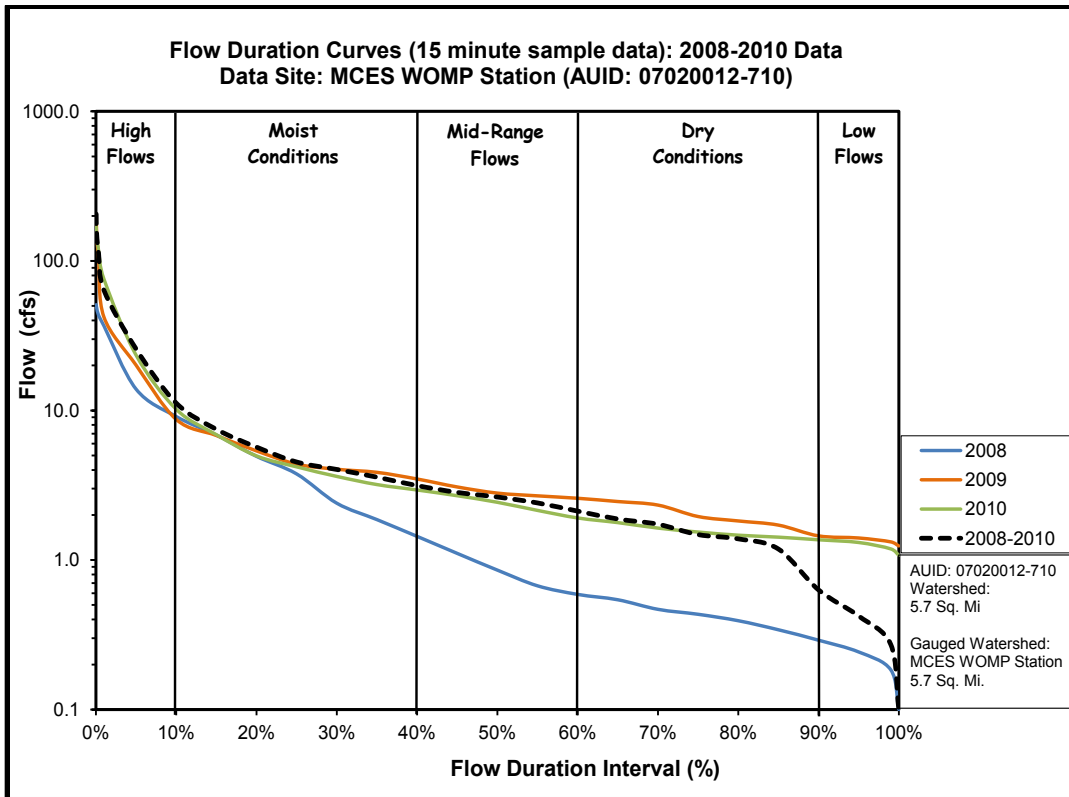
**Figure 3.8** Flow duration curve 2008-2010 using 15 minutes flow data (AUID: 07020012-710)

Flow duration curves were developed at the WOMP station (BL 3.5) for the last three years (2008, 2009 and 2010) along with a combined data set representing all three years (2008-2010). The flow duration curves rank each flow based on its percent rank. A flow duration interval of 10% represents a value where only 10% of the flow rates are higher. A 90% interval represents a low flow rate where 90% of measurements are higher. The results show 2008 as a low flow year when compared to both 2009 and 2010 ([Figure 3.8](#)). A further comparison looking at daily average flow rates for 2008, 2009 and 2010 and comparing them to historical values for the past 9 years (2002-2010) shows the same results ([Figure 3.9](#)) with 2008 having lower flow rates throughout the flow regime.

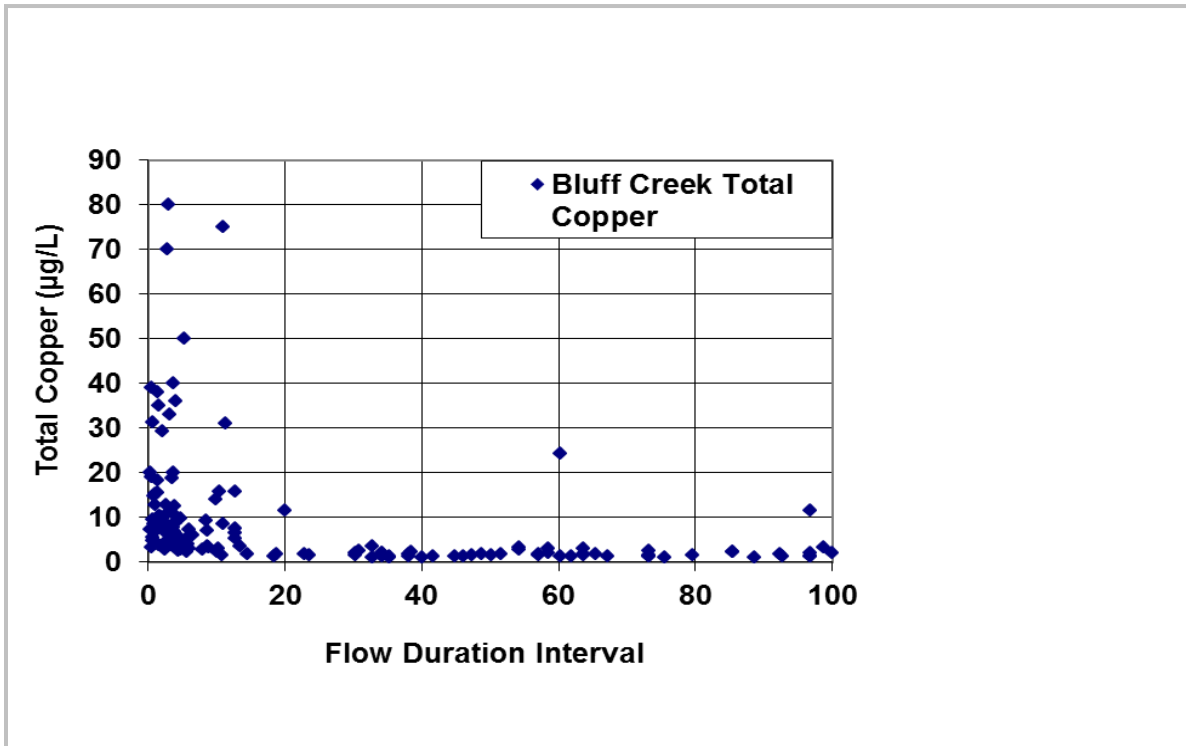
Figure 4.4 Copper water quality duration curve for bluff creek WOMP site

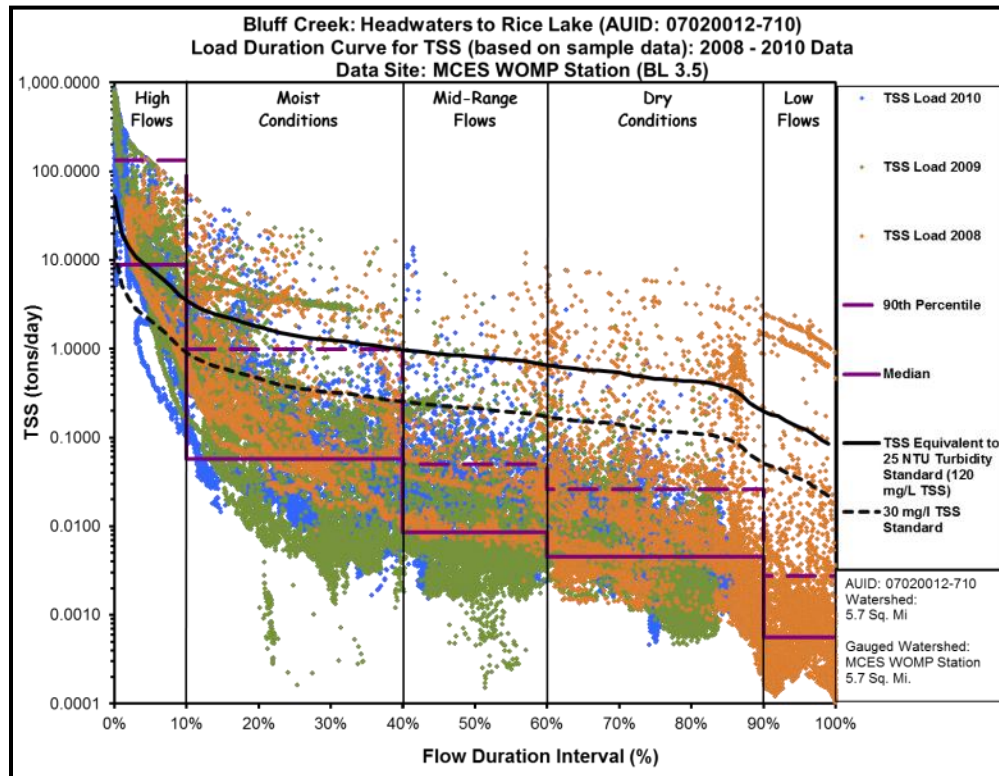
**Figure A.4. Load Duration Curve 2008-2010 (Bluff Creek WOMP)**

Load duration curves were developed showing the existing 25 NTU standard and the proposed 30 mg/L TSS standard for the three sample years (Figure A.1-A.3) and all three years combined (Figure A.4). The 90<sup>th</sup> percentile and mean values for each flow zone are also shown and are discussed in section 3.4 of the report. The 90<sup>th</sup> percentile value for both the high flow and moist conditions zones are above the 30 mg/L standard for all years and do not meet the standard requirements. The midrange flows, dry conditions and low flows all meet the standard requirements. The midrange flows, dry conditions and low flows all meet the standard requirements.

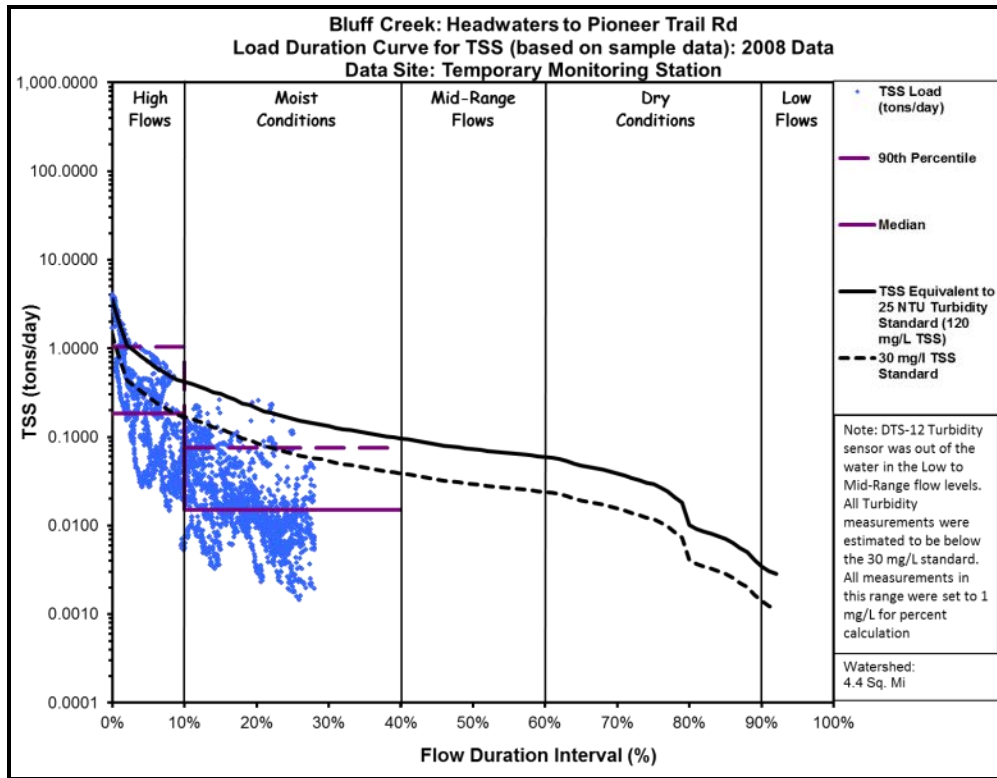
A load duration curve was developed showing the existing 25 NTU standard and the proposed 30 mg/L TSS standard for 2008 at the Pioneer Trail sample site (Figure A.5). The 90<sup>th</sup> percentile and mean values for each flow zone are also shown and are discussed in section 3.4 of the report. The 90<sup>th</sup> percentile value for both the High flow and moist conditions zones are above the 30 mg/L standard for all years and do not meet the standard requirements. The midrange flows, dry conditions and low flow data were not available for analysis.

**Figure A.5 Load Duration Curve 2008 (Pioneer Trail)**

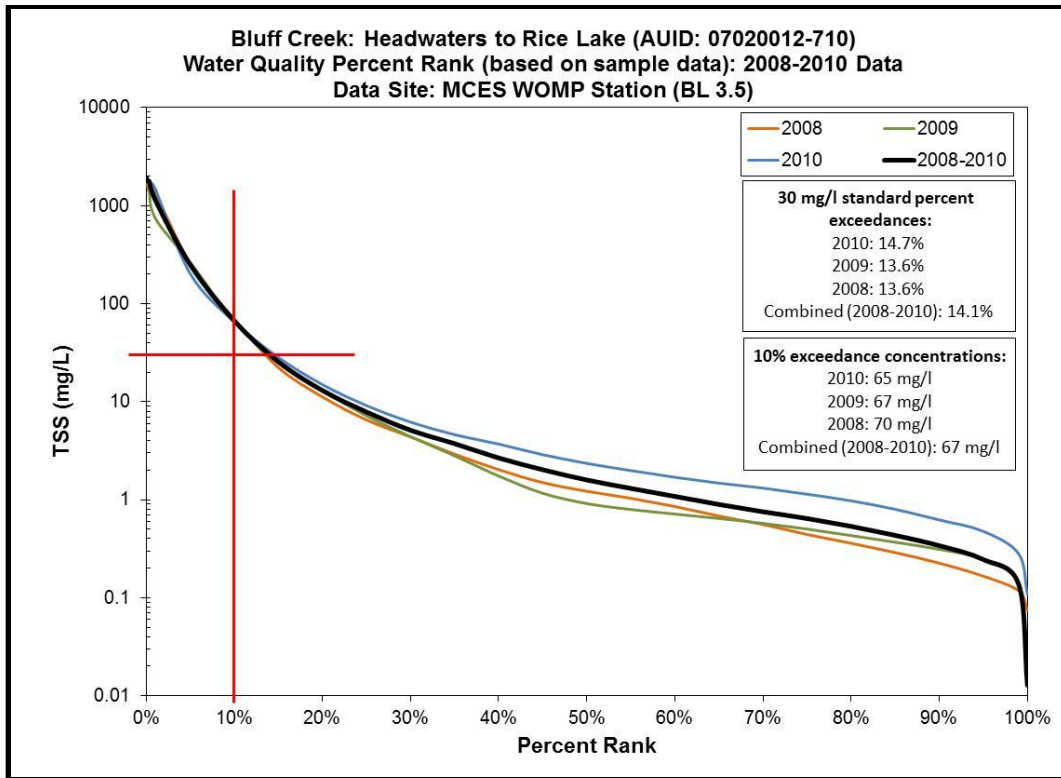
In order to meet the proposed standard the Bluff Creek WOMP (07020012-710) would have to be below 30 mg/L 90% of the time. Figure B.6 shows how the existing data at the WOMP station compares to this standard. The TSS concentrations were ranked based on the percent exceedance. The red line represents the TSS water quality standard crossing at 10% and 30 mg/L. In order to meet the standard the percent rank lines would have to cross through or below the intersection of the two standard lines. In all three years the TSS concentrations exceeded the new standard. For 2010 14.7% of the TSS measurements exceed 30 mg/L. In 2009 this number was 13.6%, 2008 it was also 13.6% and the combined 2008-2010 record exceeded 30 mg/L 14.1% of the time. The 10% exceedance concentrations were 65, 67, 70 and 67 mg/L for the 2010, 2009, 2008, and the combined (2008-2010) data sets. This is more than double the 30 mg/L standard.

**Figure A.5 Water Quality Percent Rank (Bluff Creek WOMP)**

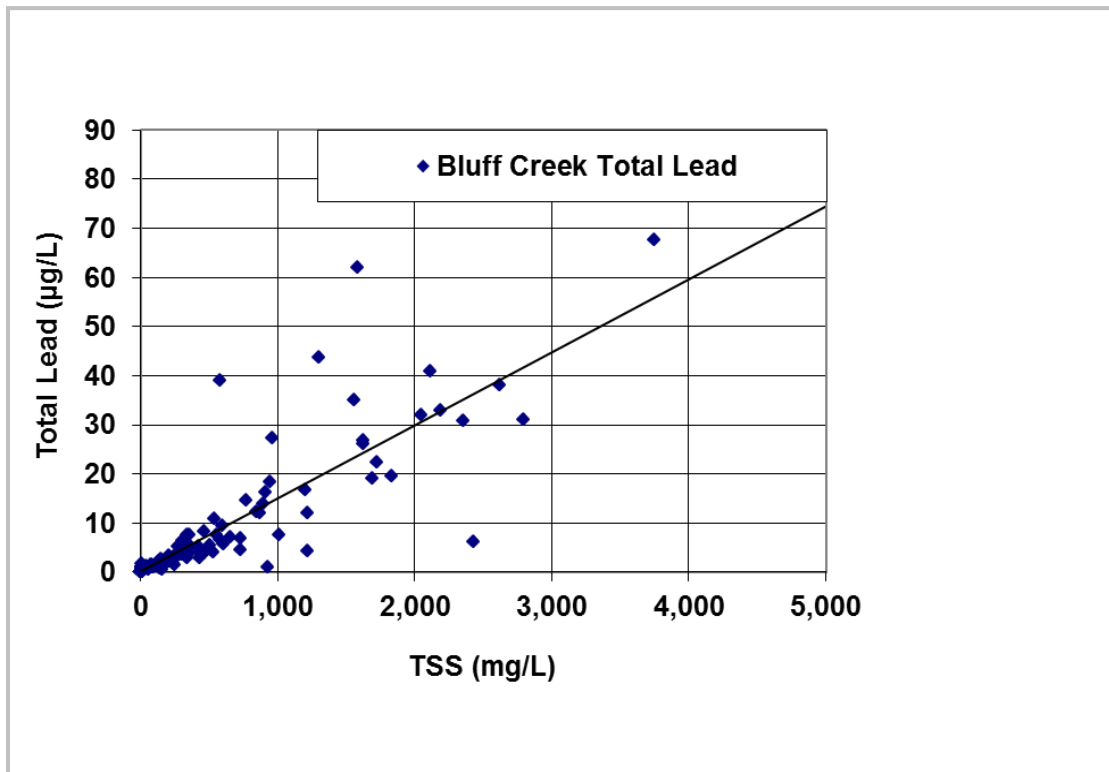
Figure D.1 Lead versus suspended solids for Bluff Creek WOMP site

A second stressor - metals – may also be addressed by achieving TMDL wasteload and load allocations through this TMDL. The data indicate metals are entering Bluff Creek with sediment during periods of high flow (Figures D.1 through D.6). Hence, sediment load reductions will also reduce metal loads to Bluff Creek.

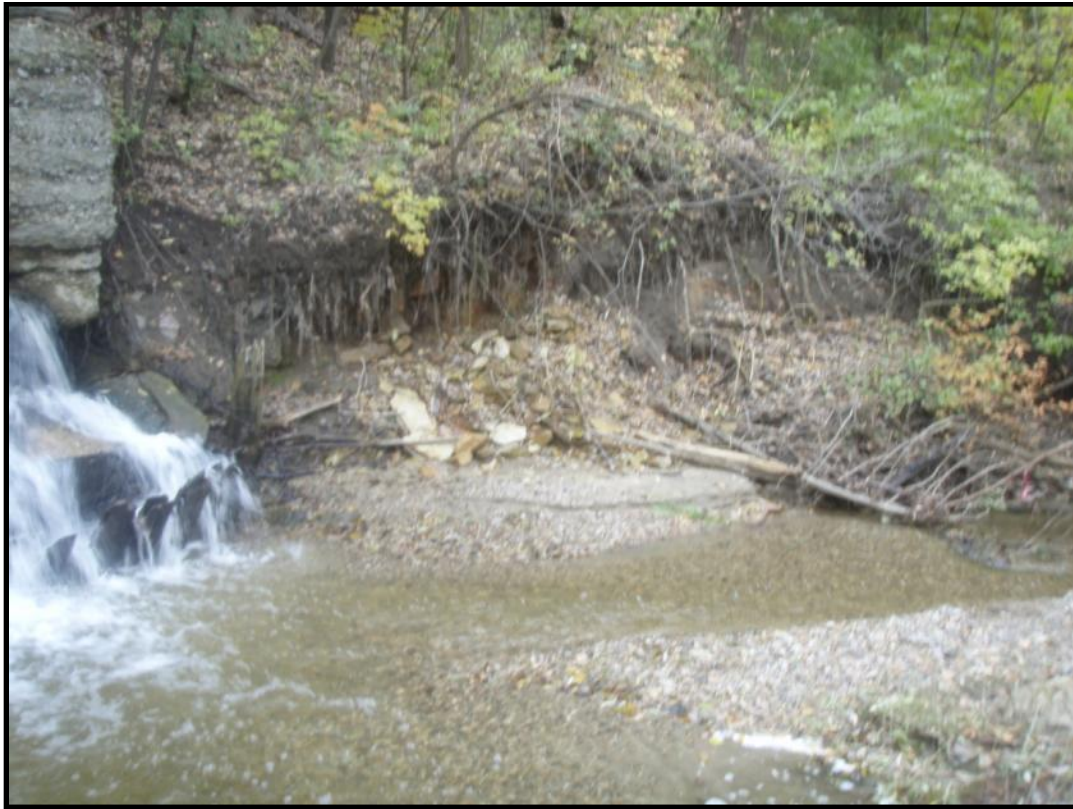
**Figure D.8 Eroding left stream bank immediately downstream of culvert outlet**
