Protecting Lake Susan

Lake Susan₂₀₁₅ **Riley Purgatory Bluff Creek Watershed District**

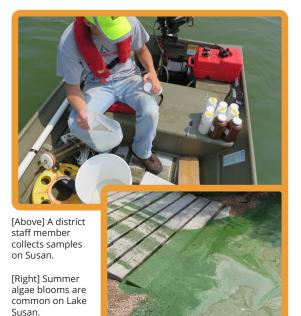
Susan is classified as a "Shallow Lake", which means that it is generally less than 15 feet deep and light can reach the bottom in most of the lake. To be considered healthy by the MPCA, shallow lakes need to be clear enough to see 1 meter down, and have low TP and Chl-a levels. These shallow lake standards are listed in the summary table.

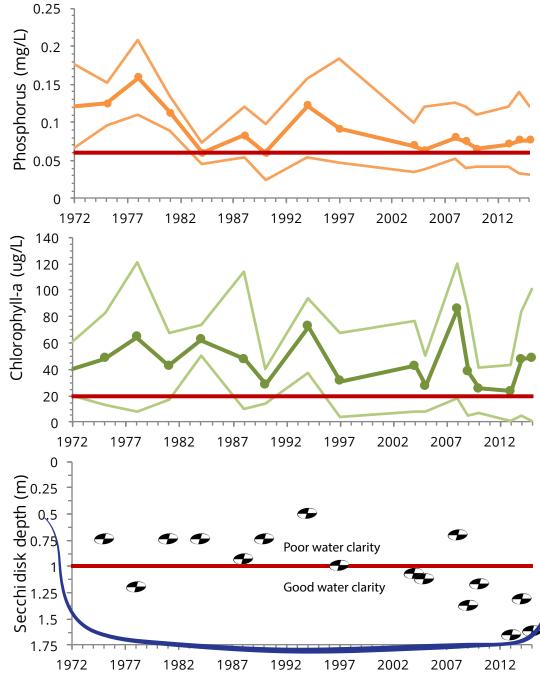
The graphs on the next page show the trends over time. The red line on each graph marks the MPCA standard. The goal for each graph is for the average values (the dots) to be below the red line.
