City of Chanhassen Facilities Planning Study

Council Workshop Presentation
10 January 2022

SNOW
KREILICH
ARCHITECTS

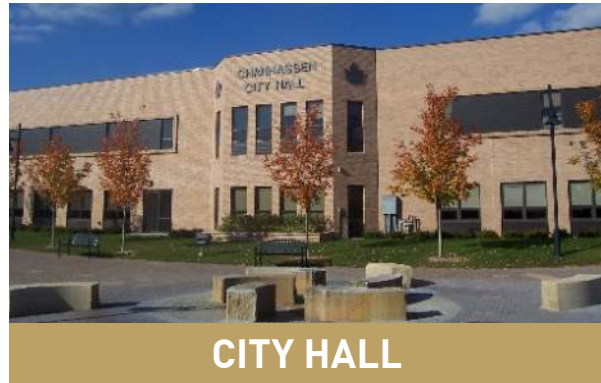
CITY HALL

FCI = CRITICAL

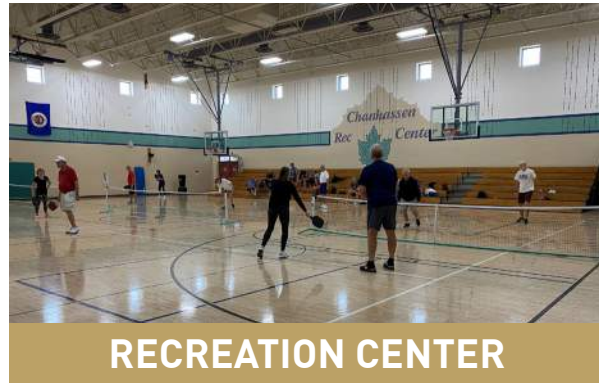
RECREATION CENTER

FCI = POOR

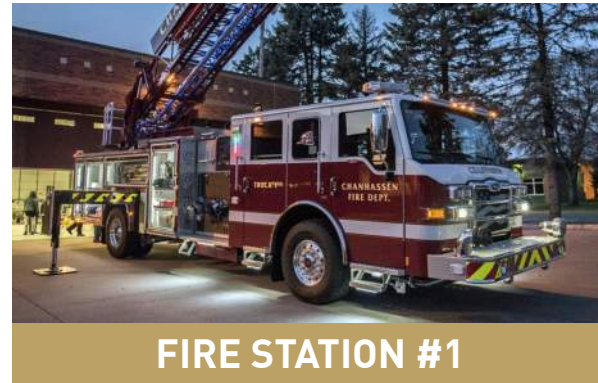
FIRE STATION #1

FCI = FAIR

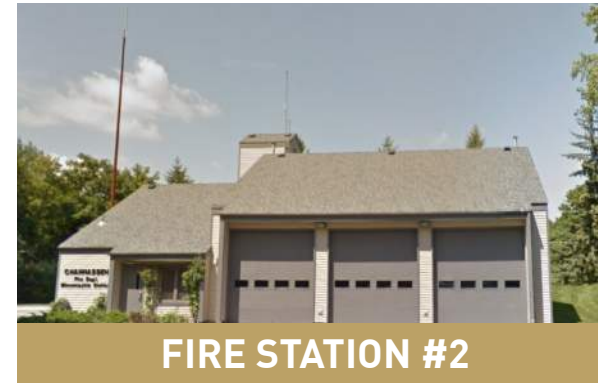
FIRE STATION #2

FCI = CRITICAL

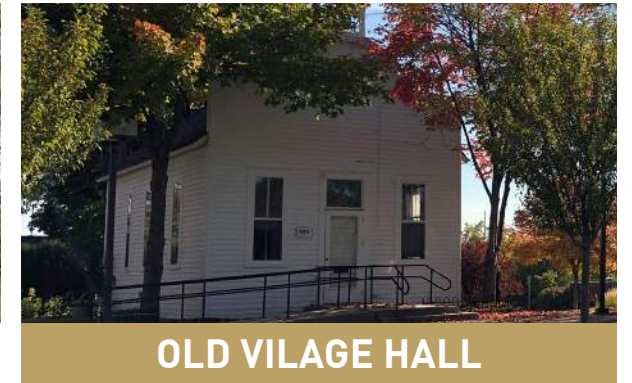
OLD VILAGE HALL

FCI = POOR

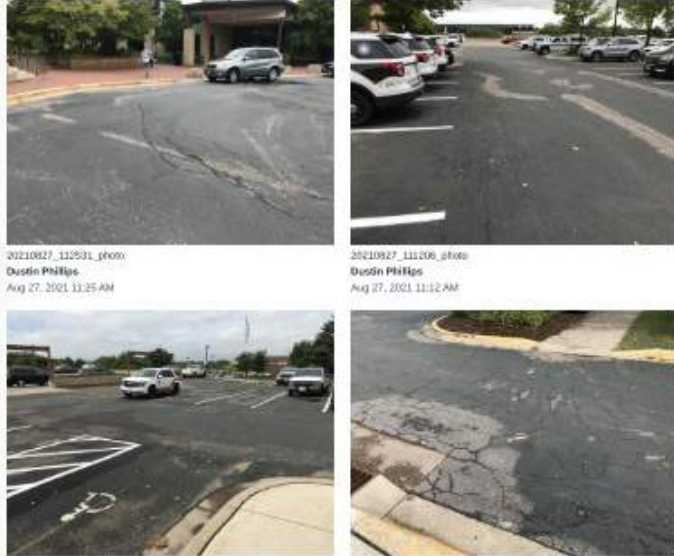
Description
Parking lot has had a chip seal done in the past but is due for mill and overlay at next cycle. See images for cracking and deterioration.

20210827_112531_photo
Dustin Phillips
Aug 27, 2021 11:25 AM

List
Replace (like for like)

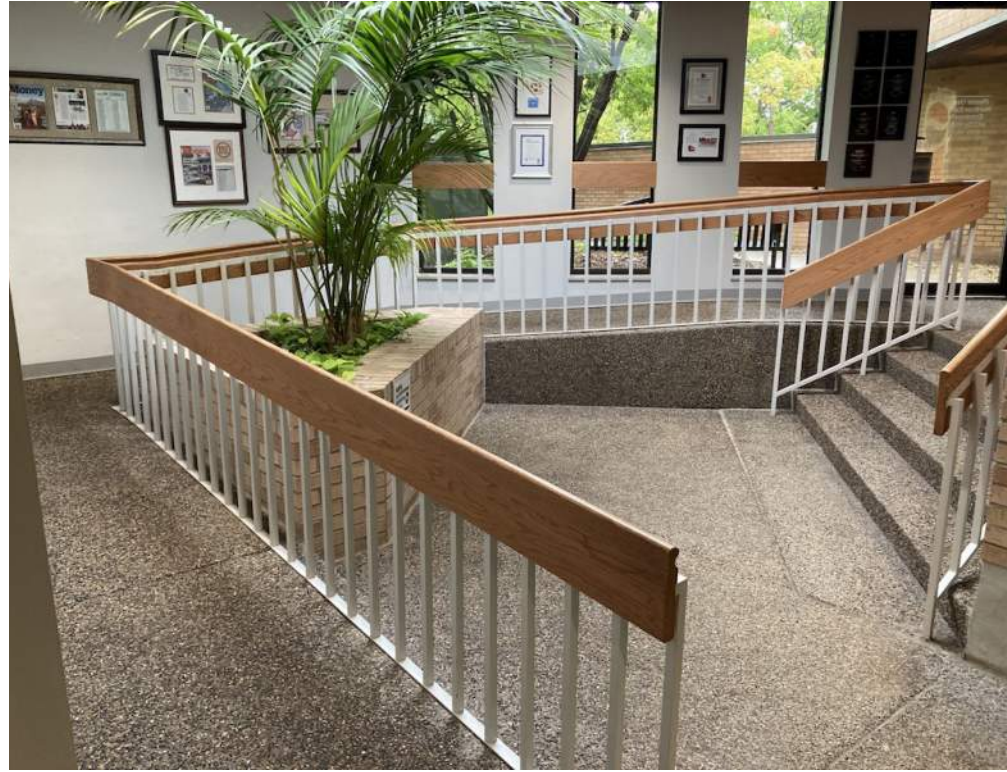
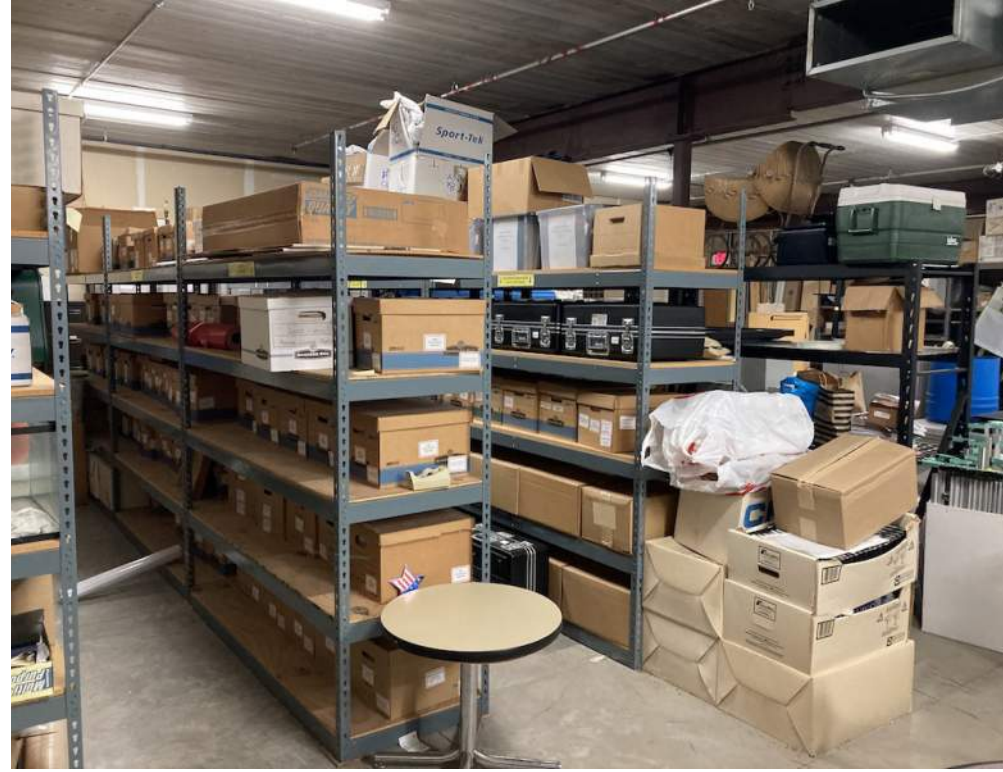
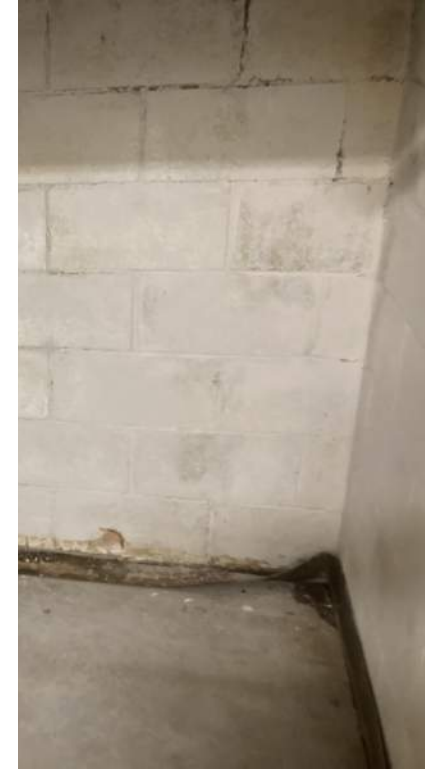
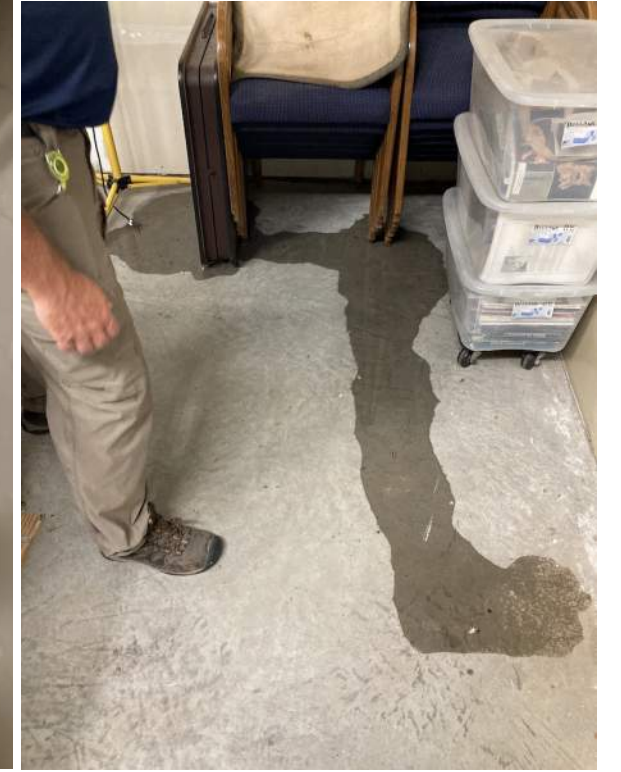
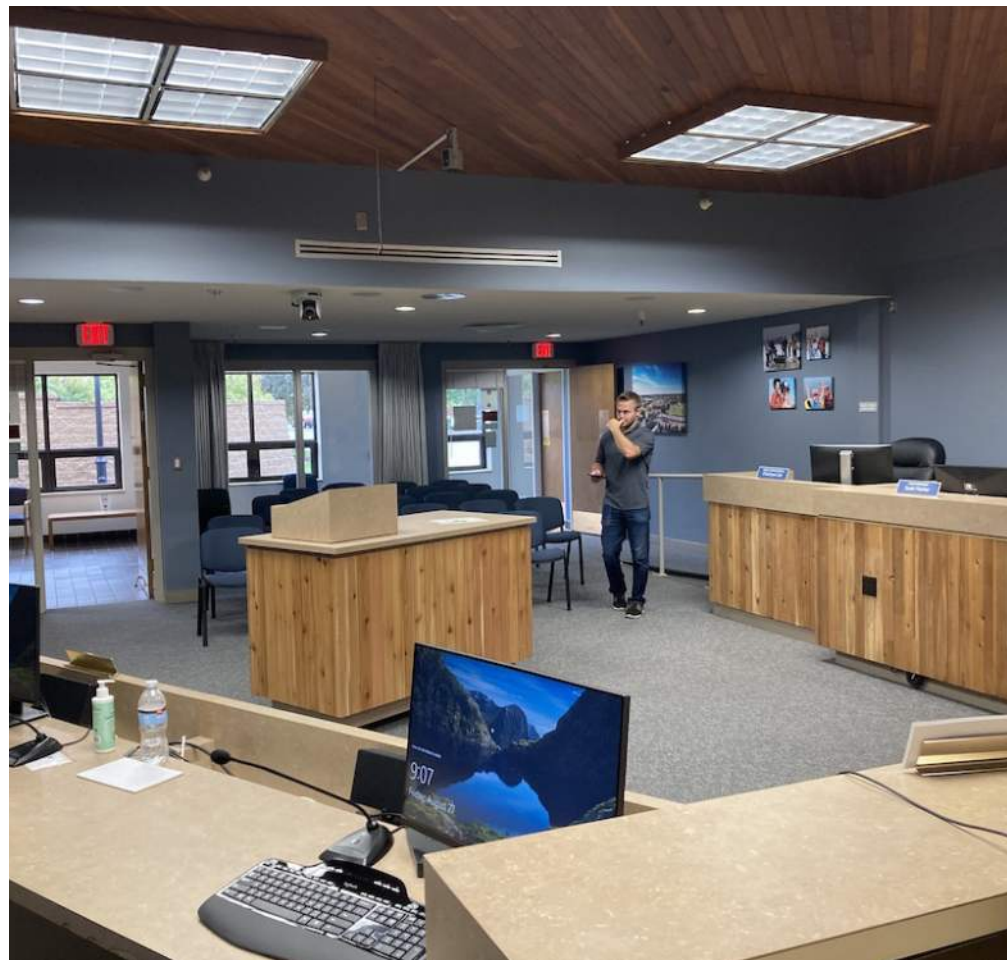
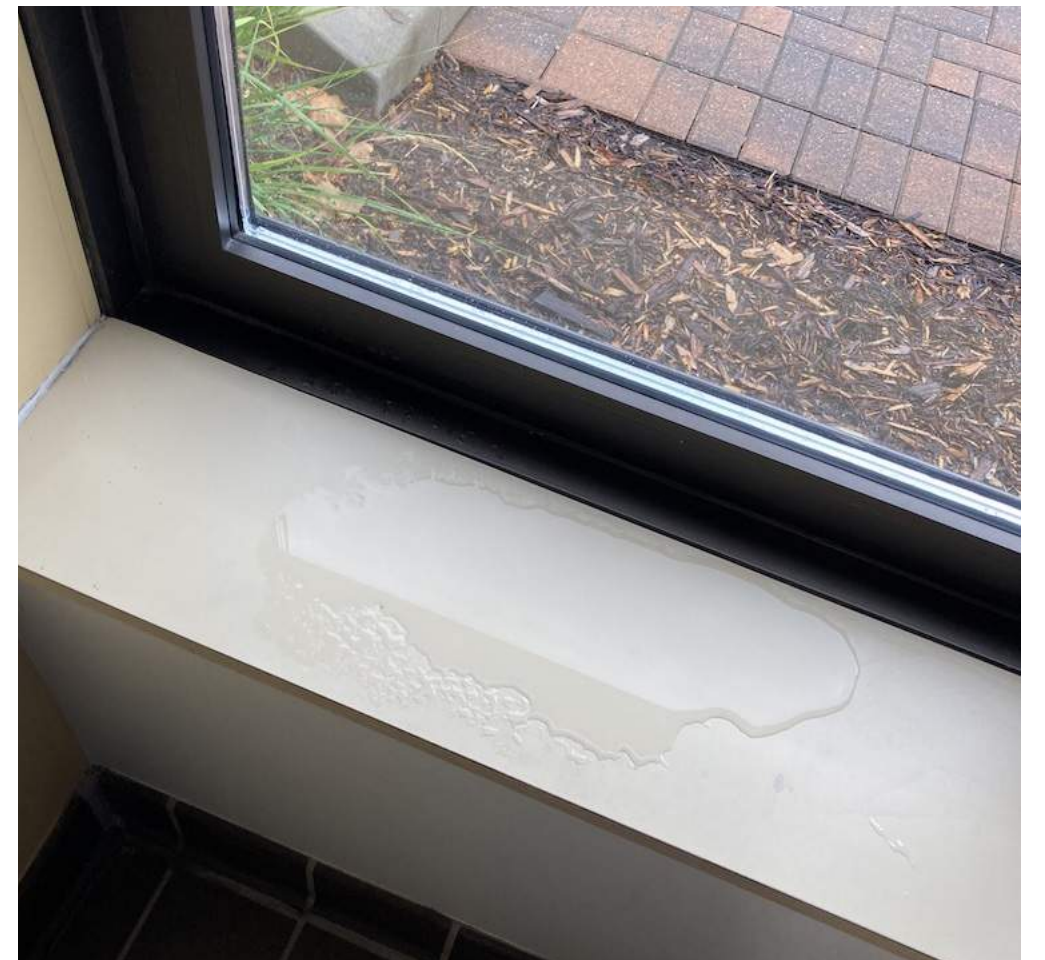
- Minimal / no insulation used
- No barrier to air infiltration / leakage
- Outdated technology / does not meet current code required minimum performance levels
- Interior side insulation has higher potential for mold growth / wall deterioration

air leakage / high condensation & frost potential

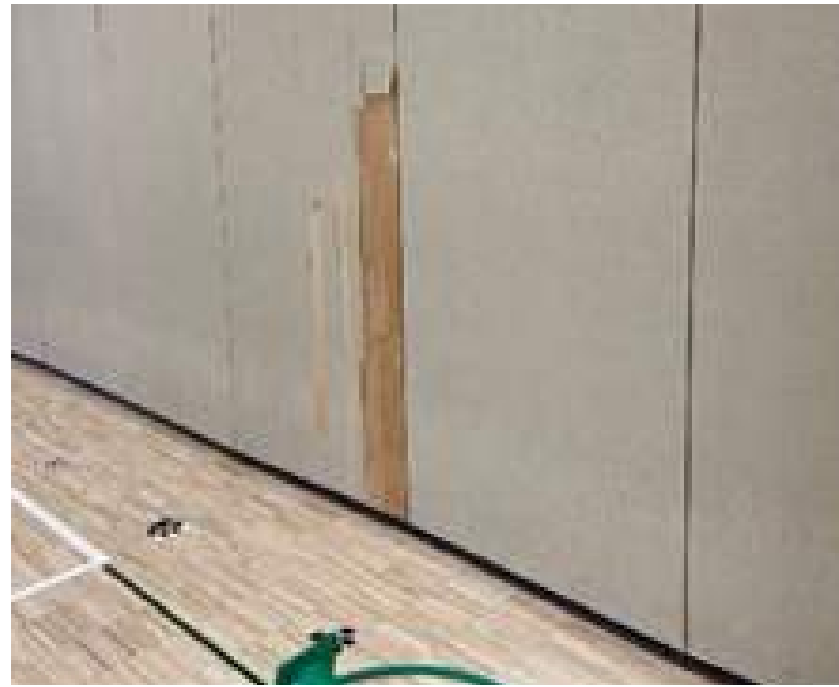
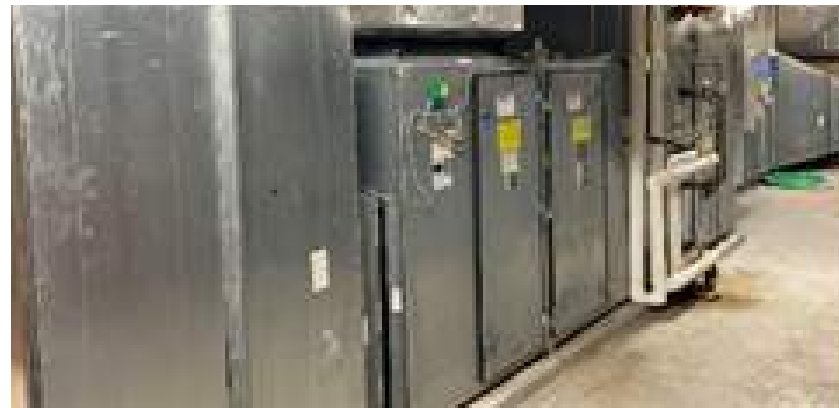
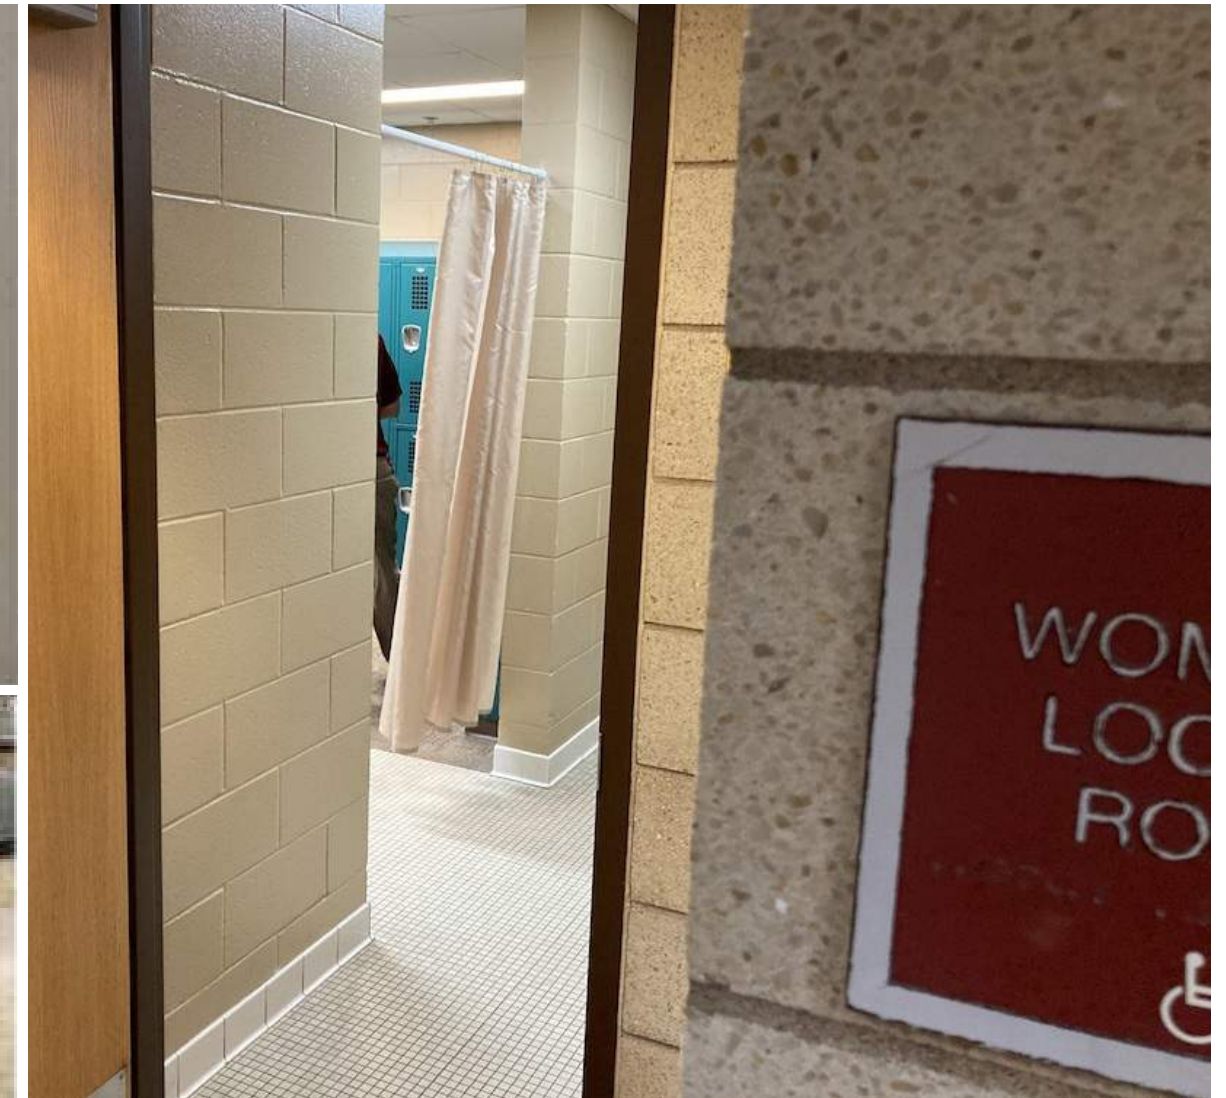
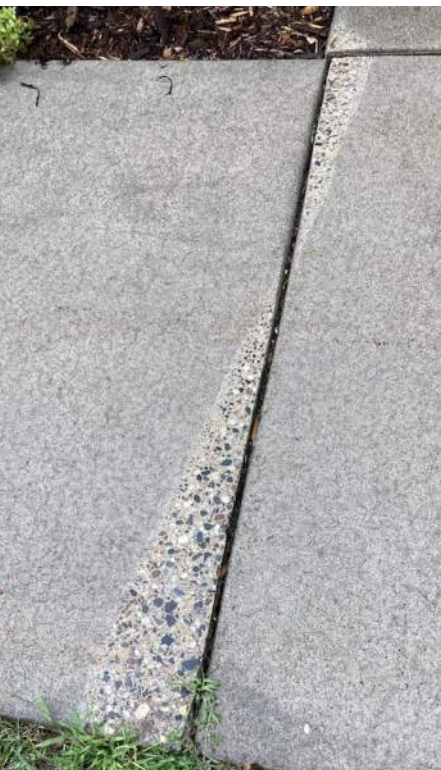
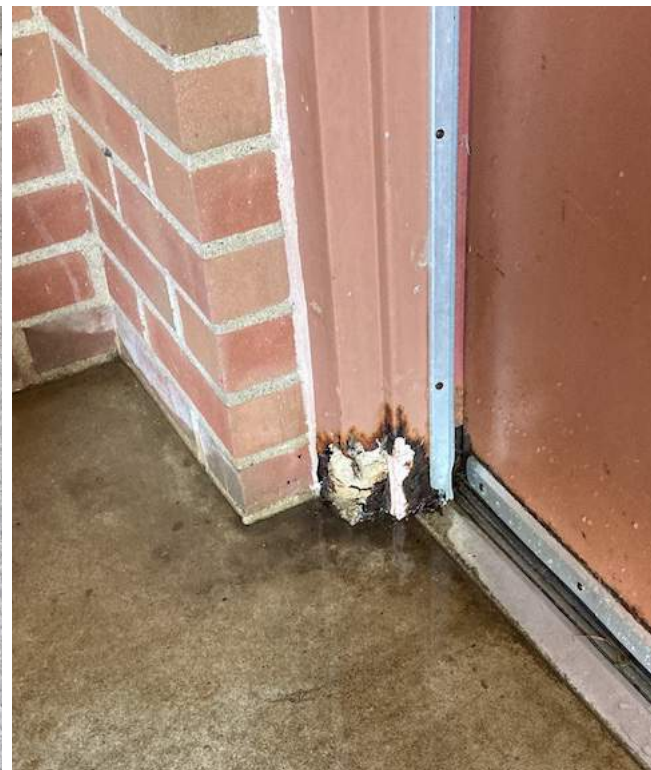
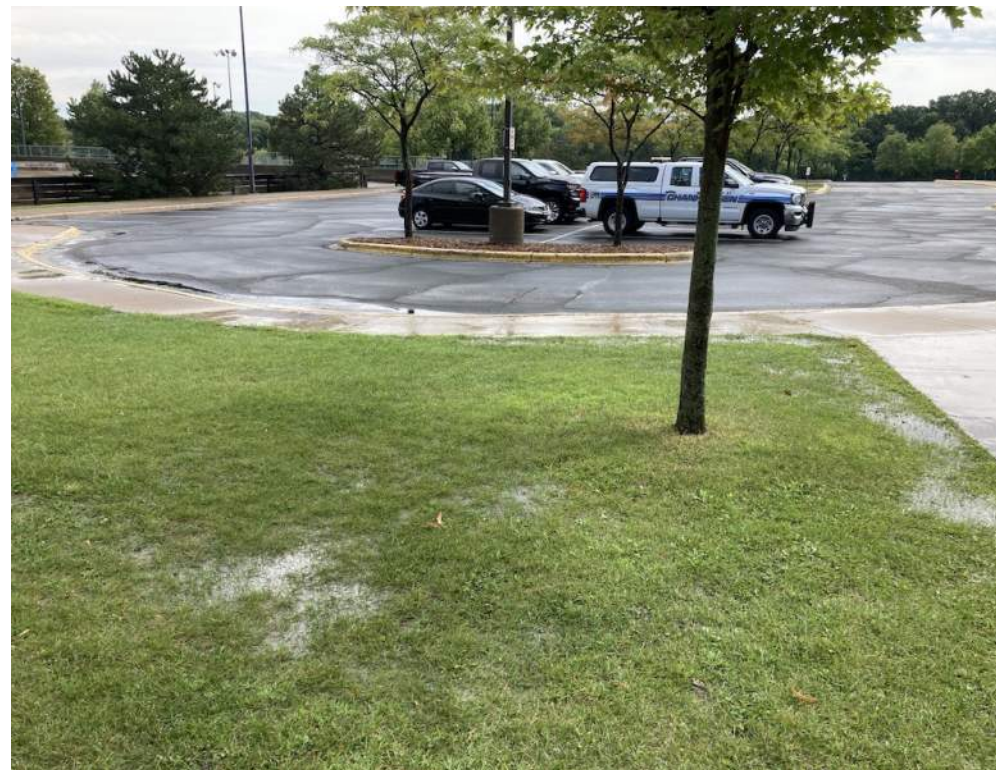
- Cavity insulation used (Typical of building age)
- Limited barrier to air infiltration / leakage (discontinuous)
- Outdated technology / does not meet current code required minimum performance levels

air leakage / high condensation & frost potential

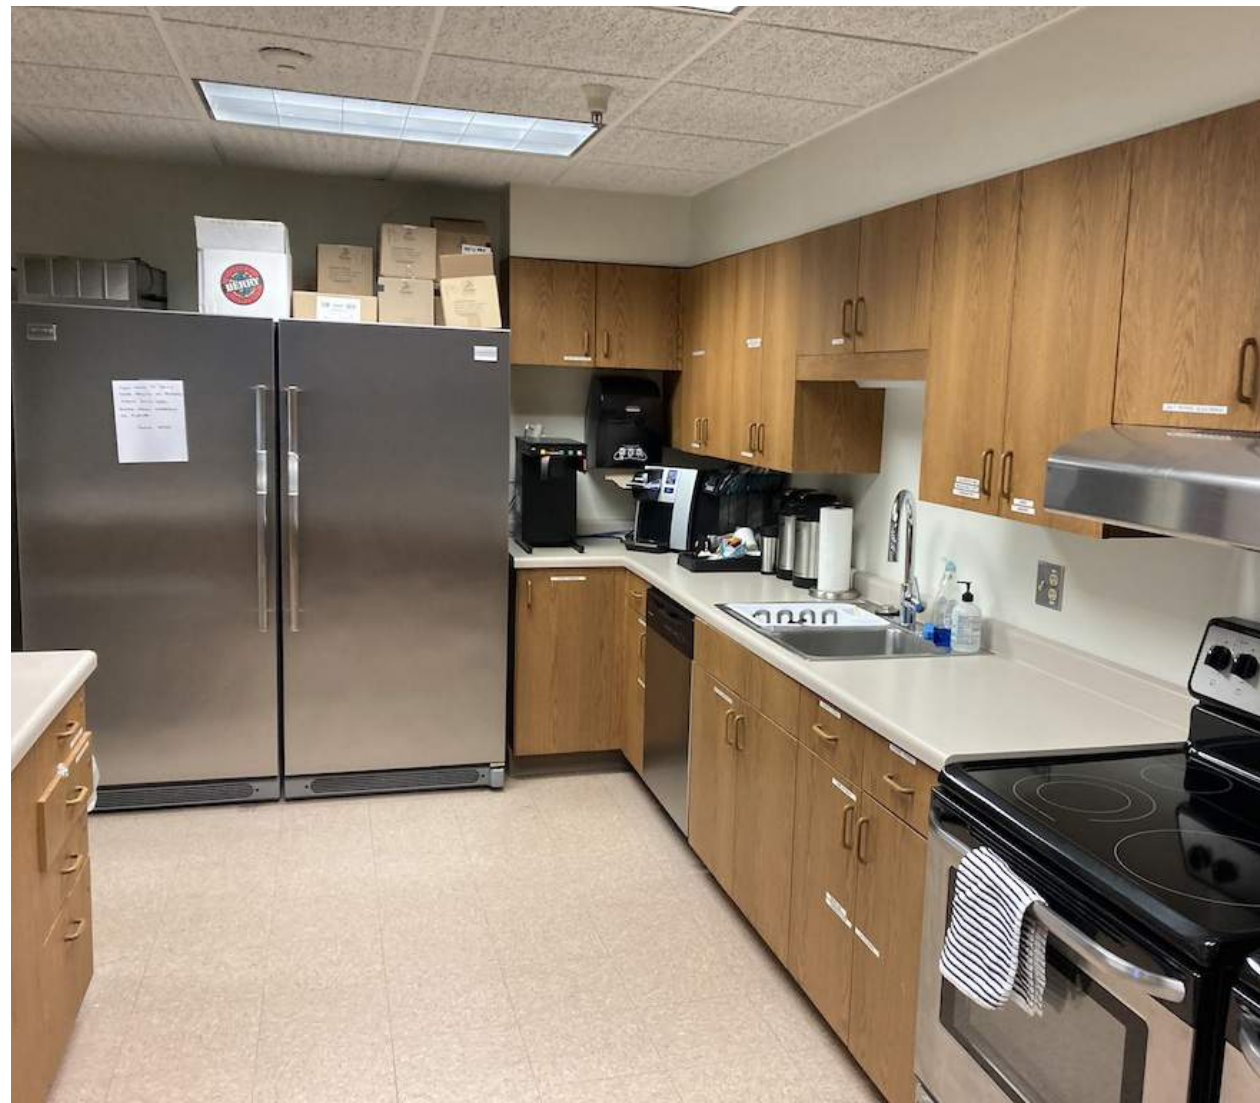
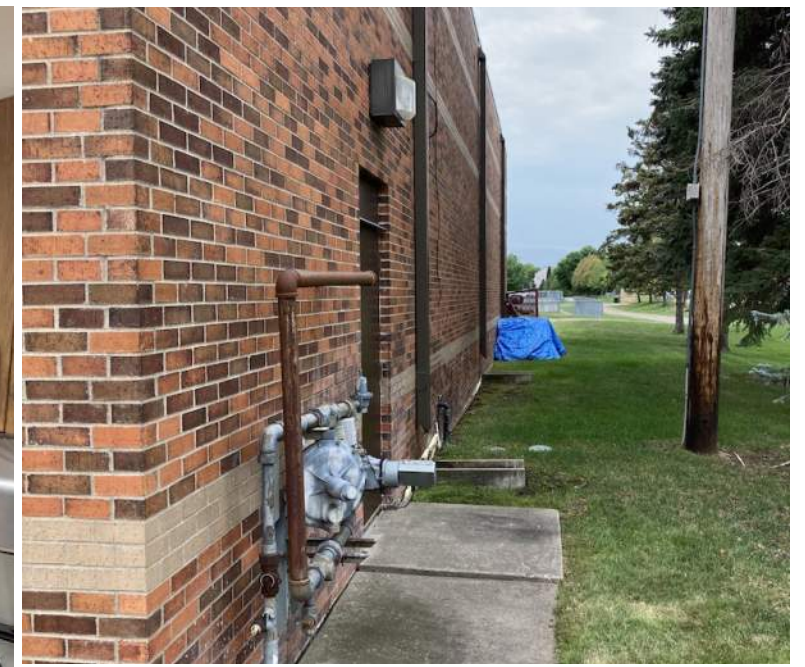
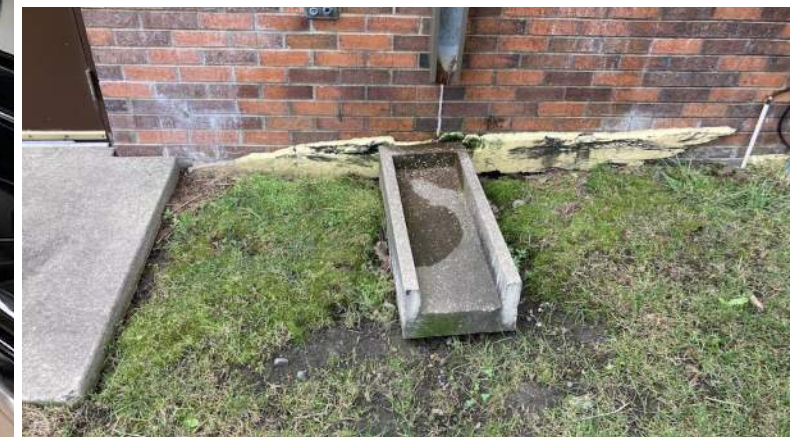
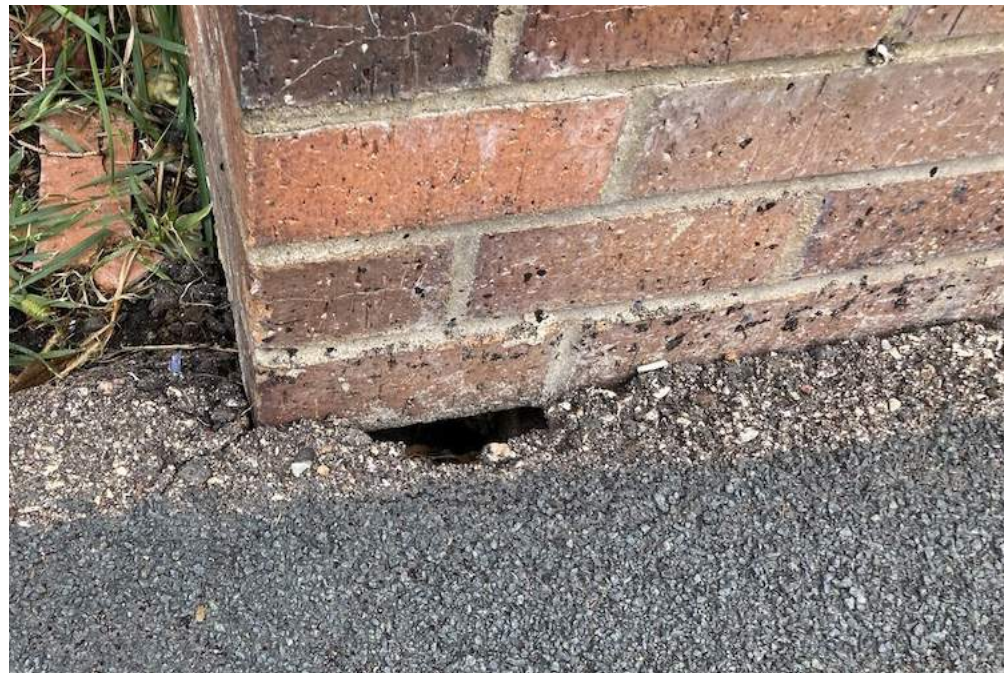
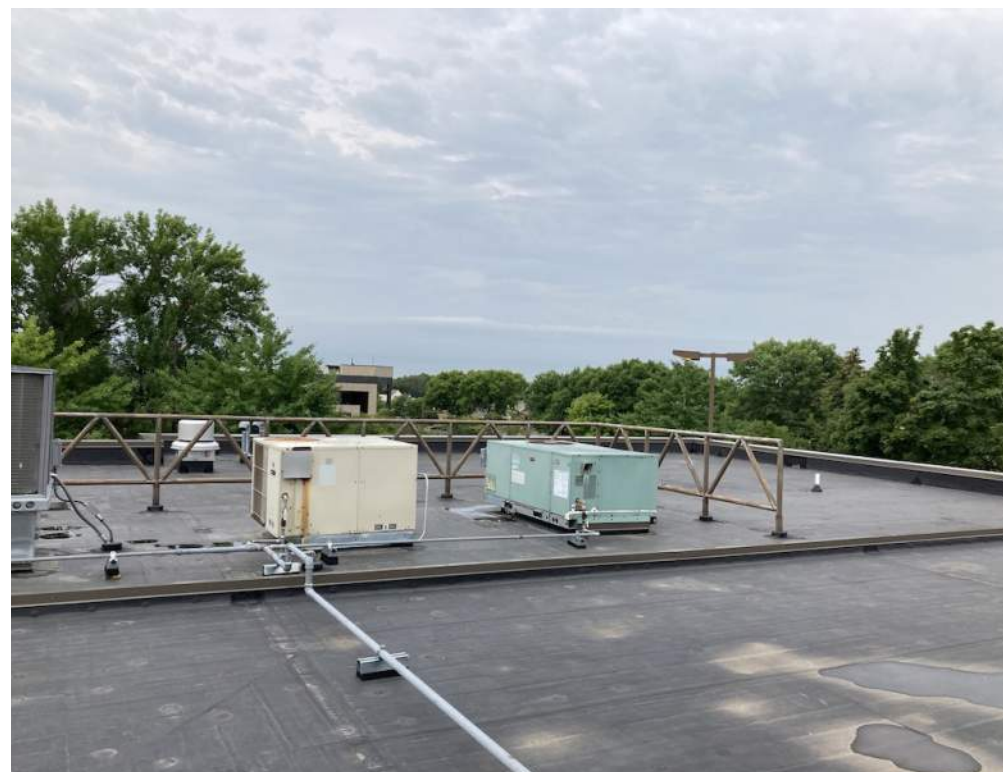
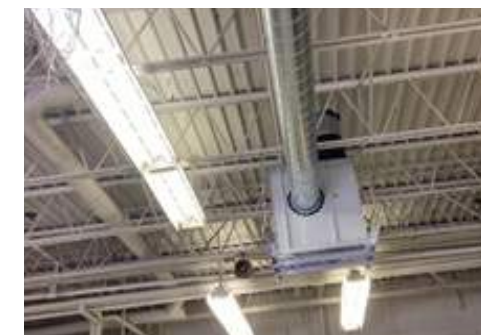
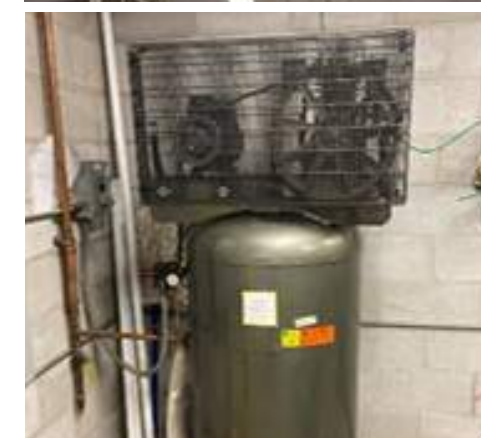
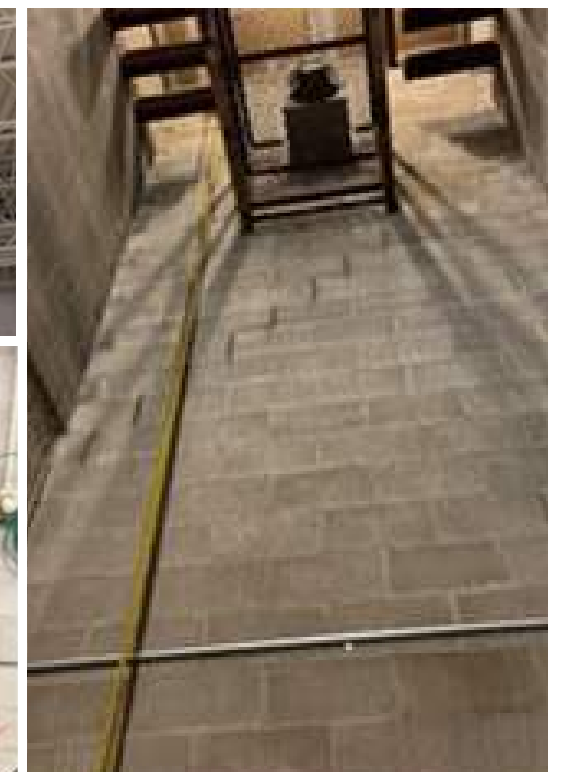
- General maintenance
- ADA compliance
- Equipment upgrades
- Site grading / drainage
- Skylight repair
- Functional updates
- Cosmetic updates

uninsulated steel column - exposed to weather and subject to frost / ice build-up

air leakage at batt insulation / high condensation & mold potential
air leakage / high condensation & frost potential

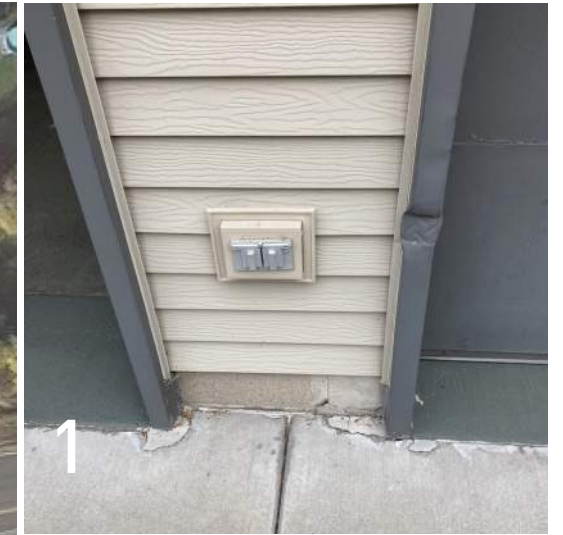
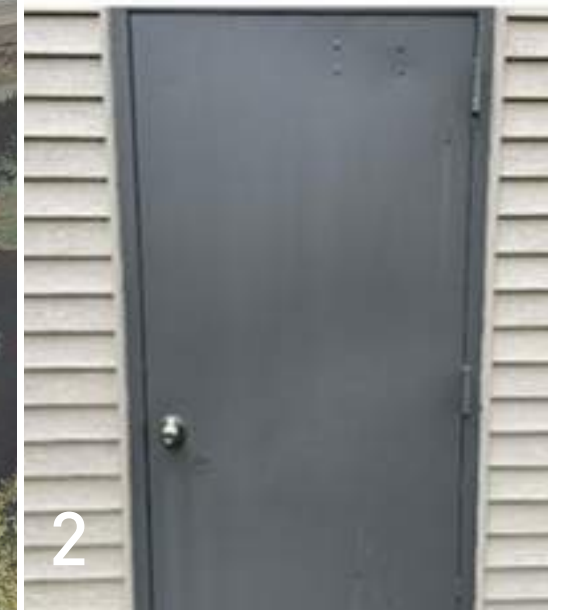
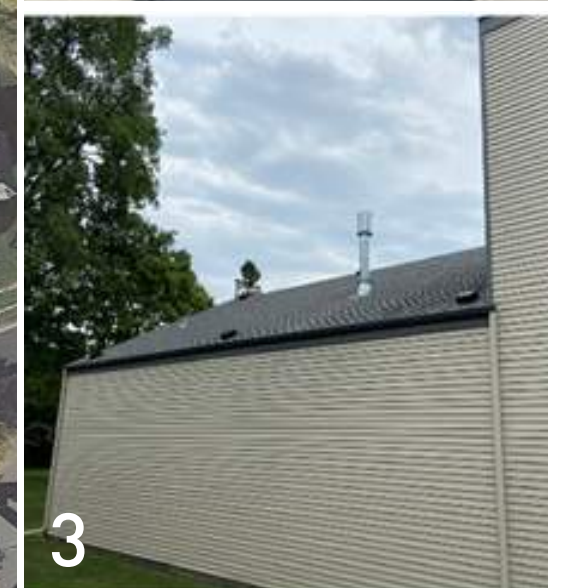
- » Repair frame of garage door
- » Replace exterior door from bay

- » Sealcoat of parking lot

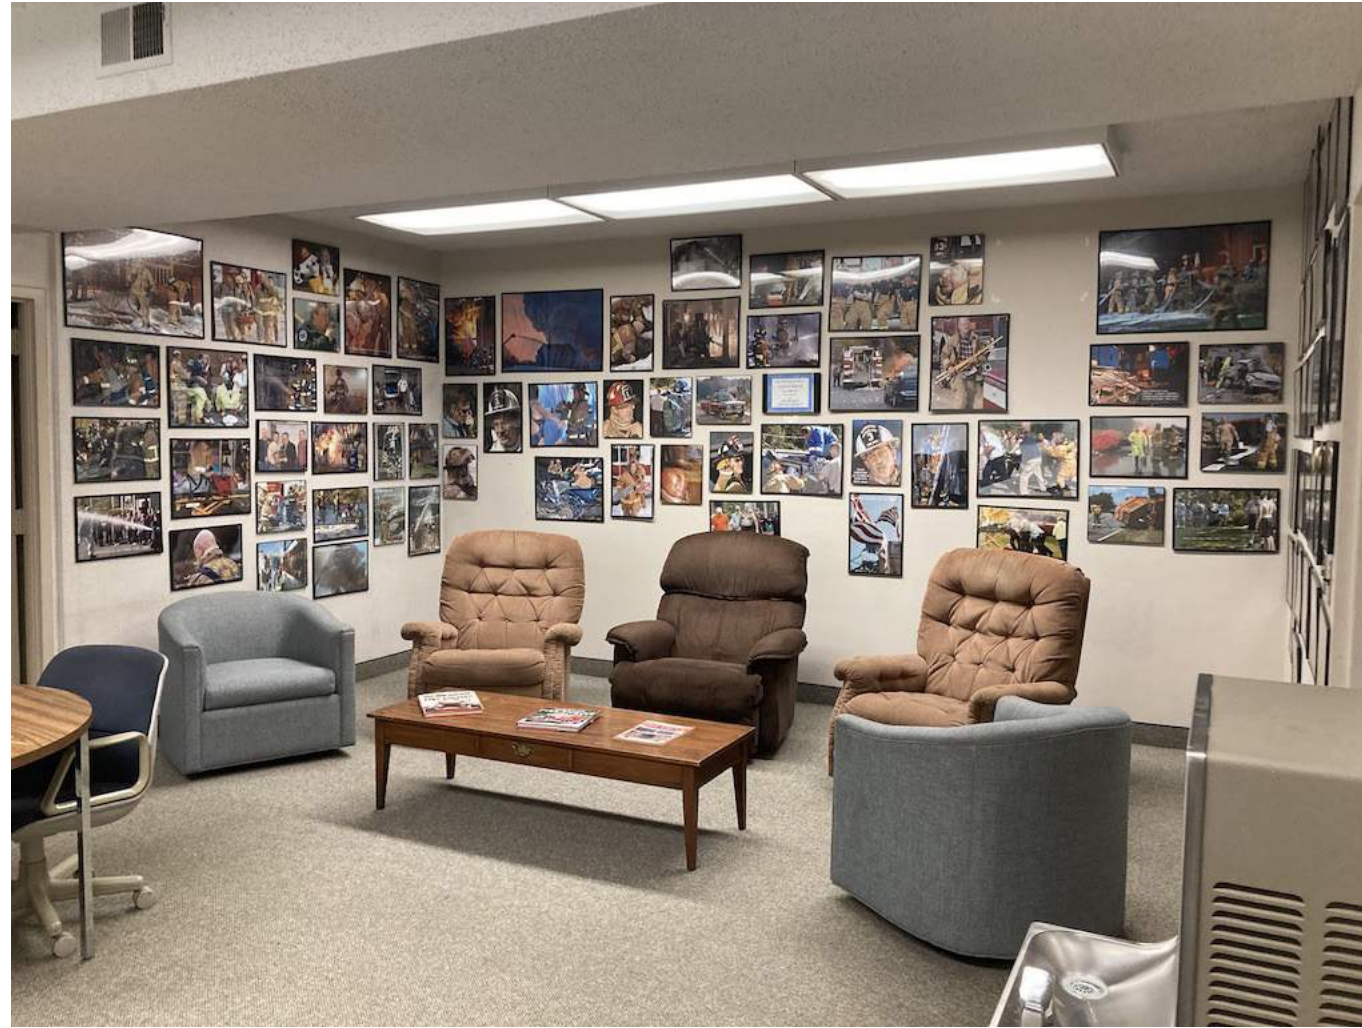
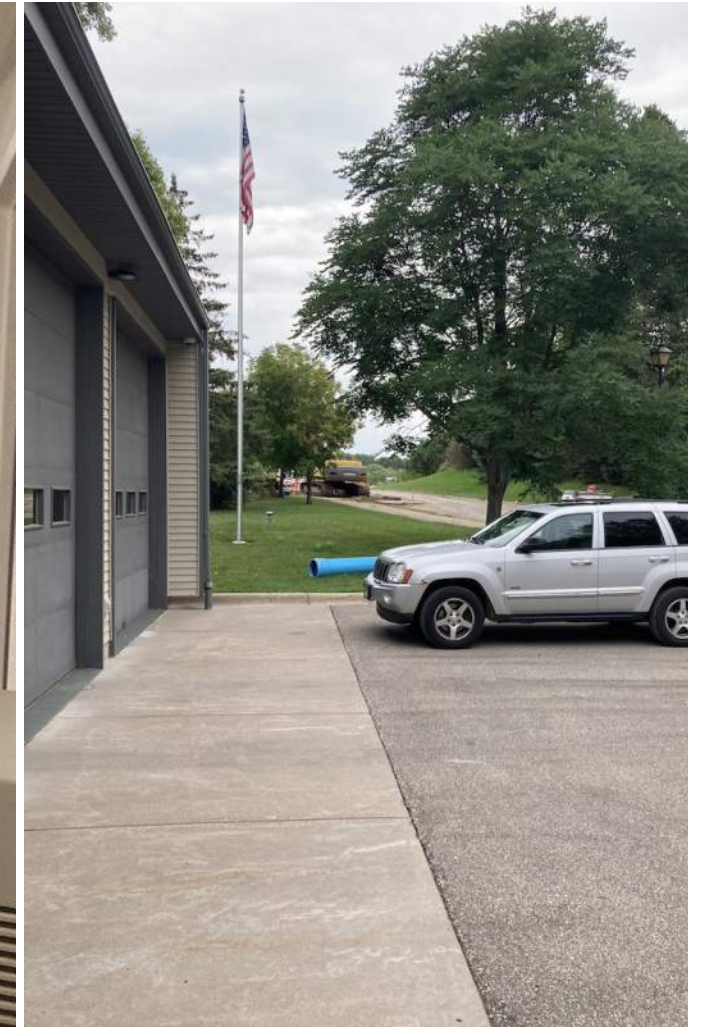
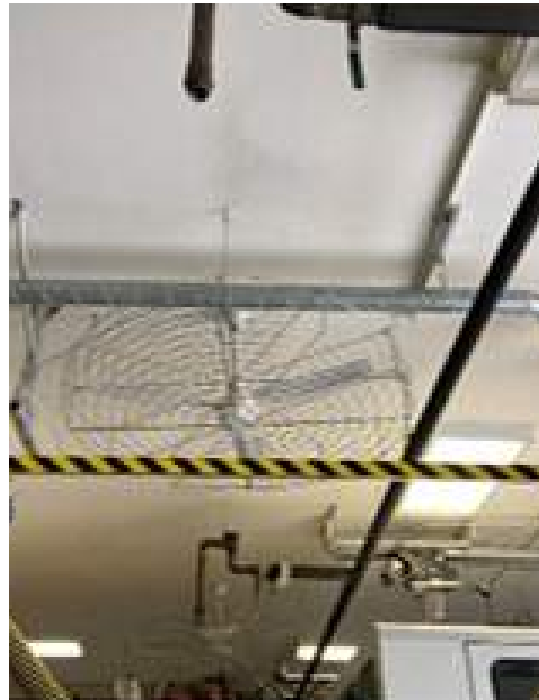
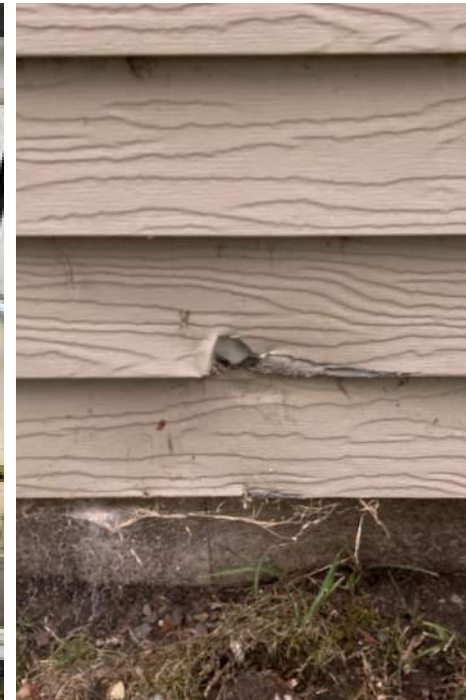
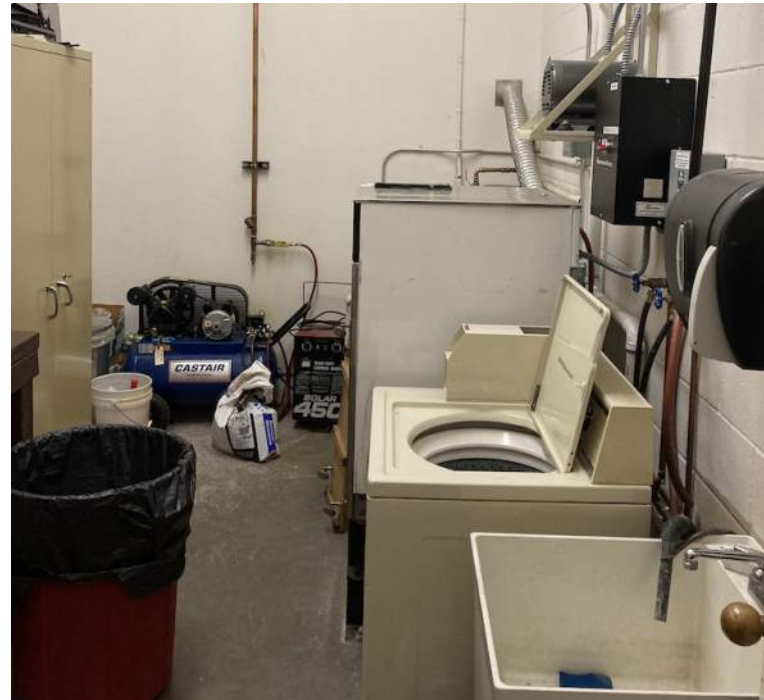
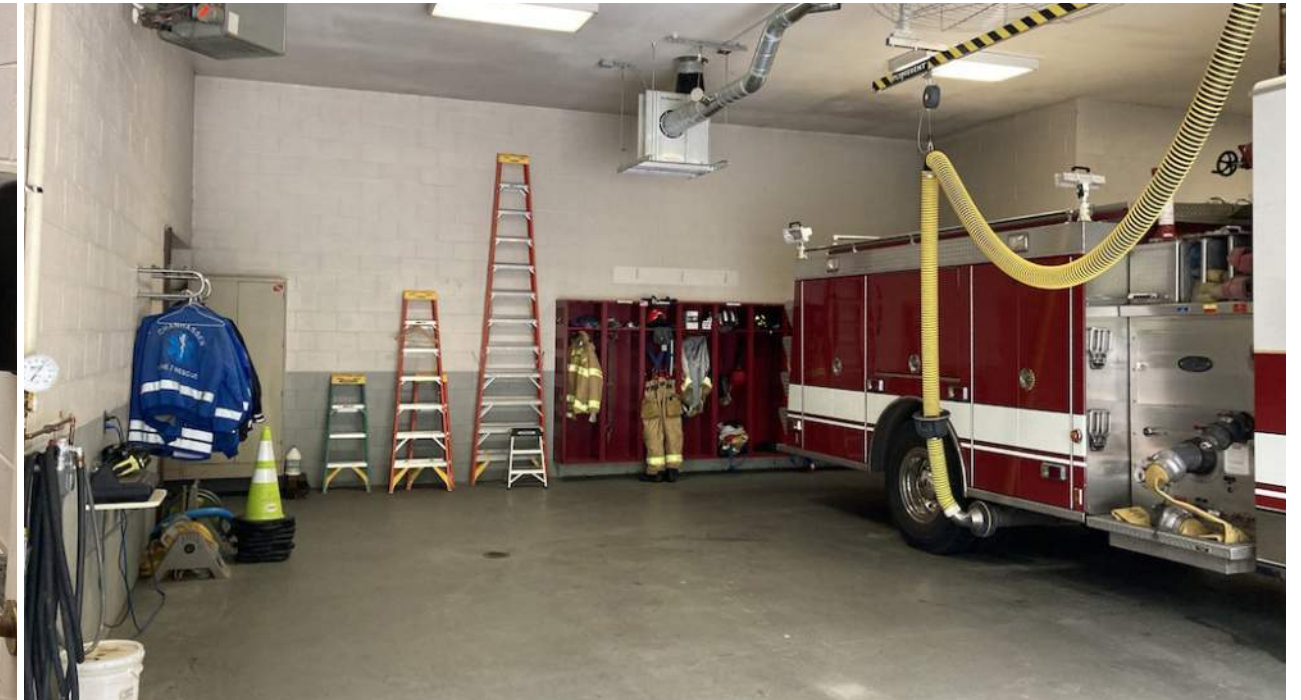
- General maintenance
- ADA compliance
- Hose tower safety concerns
- Equipment upgrades
- Functional updates
- Cosmetic updates

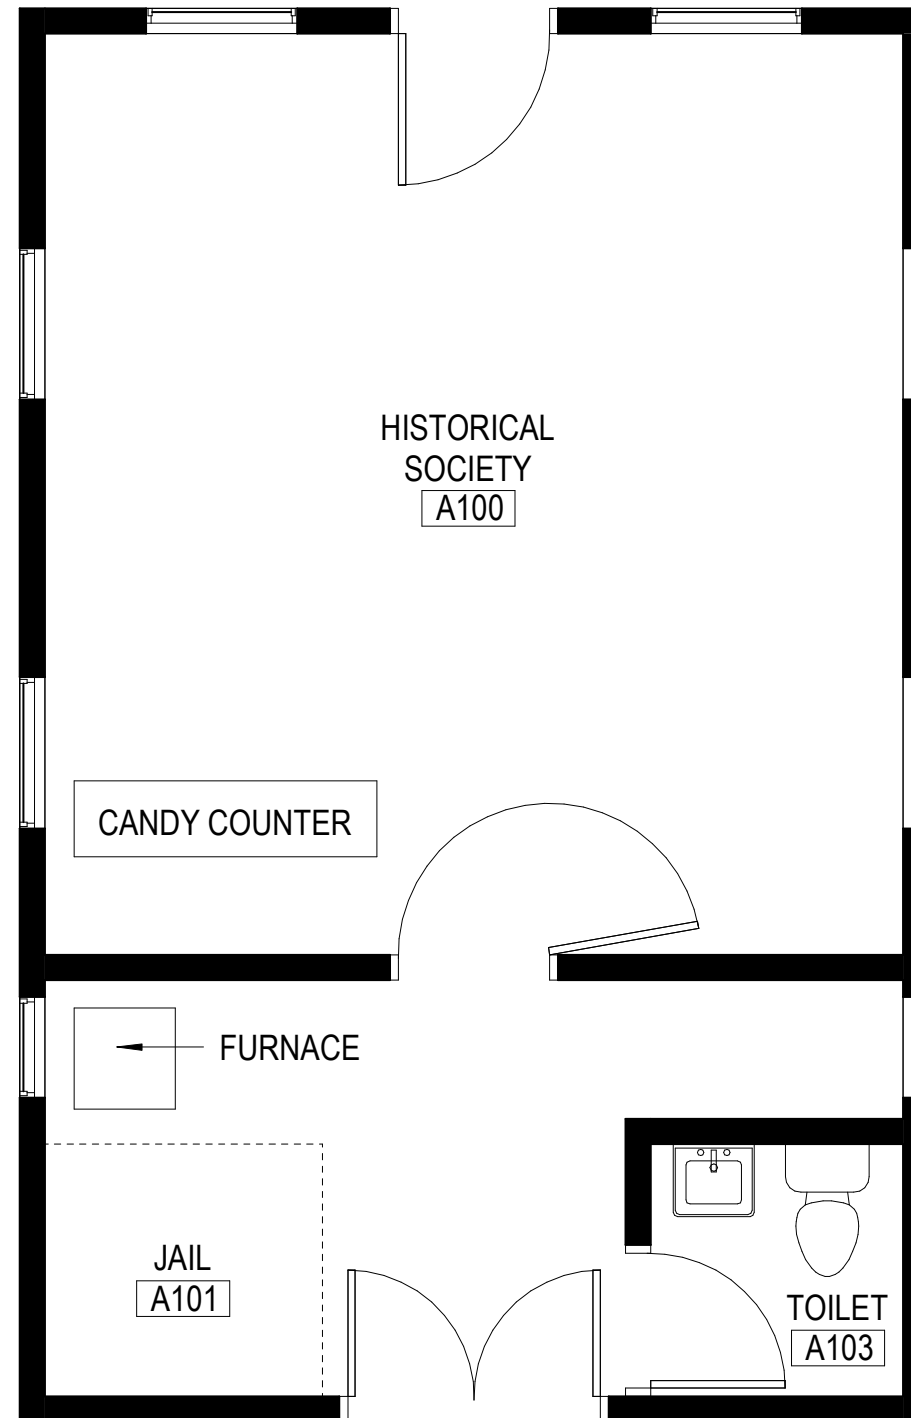
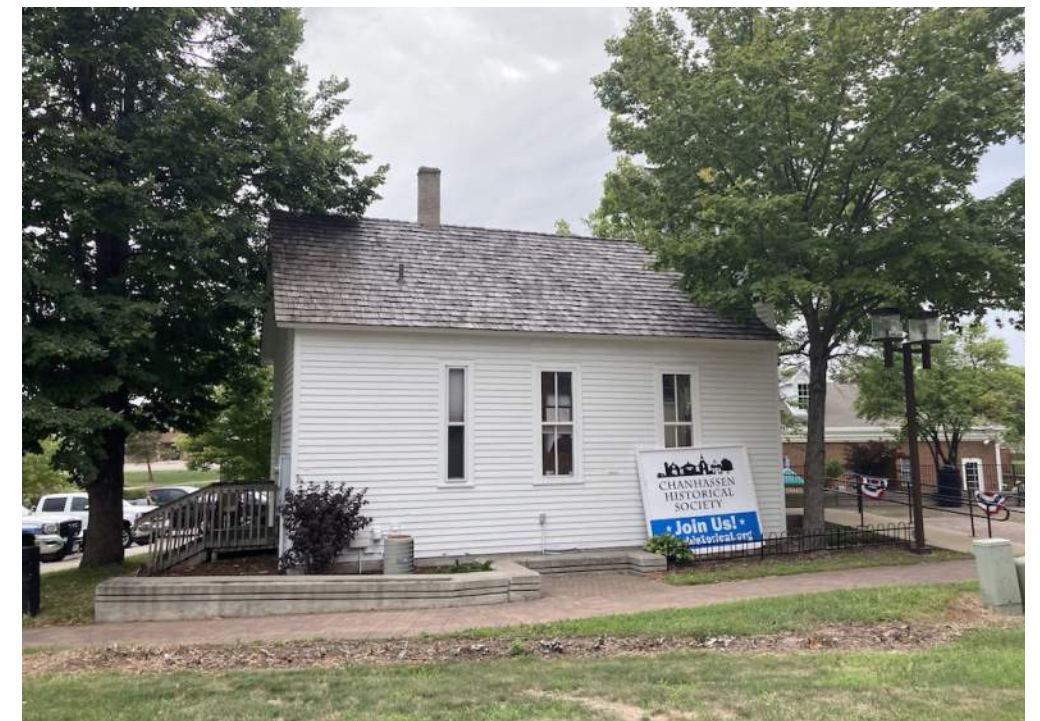
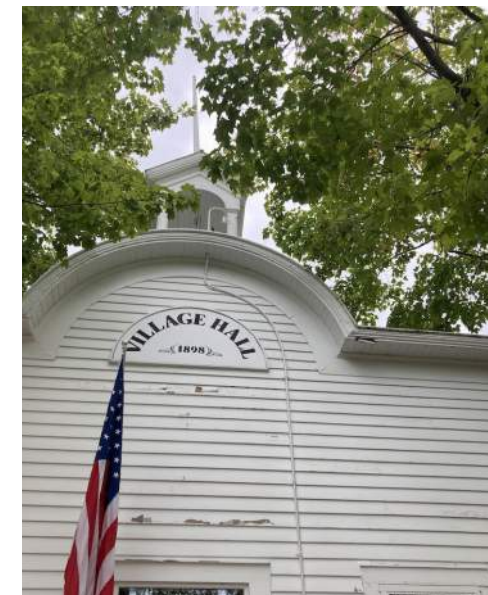
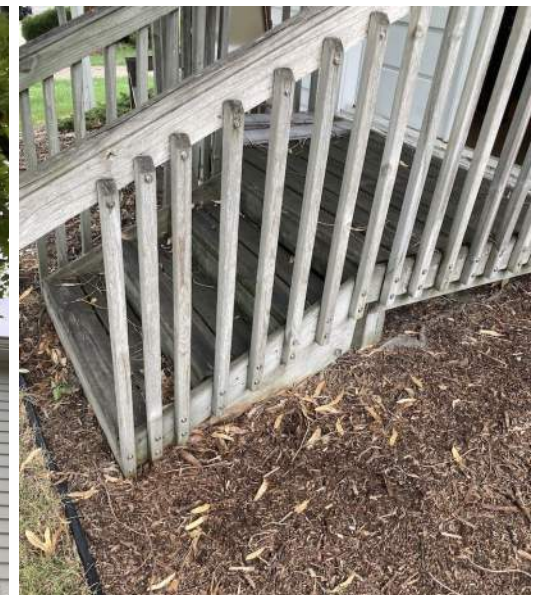
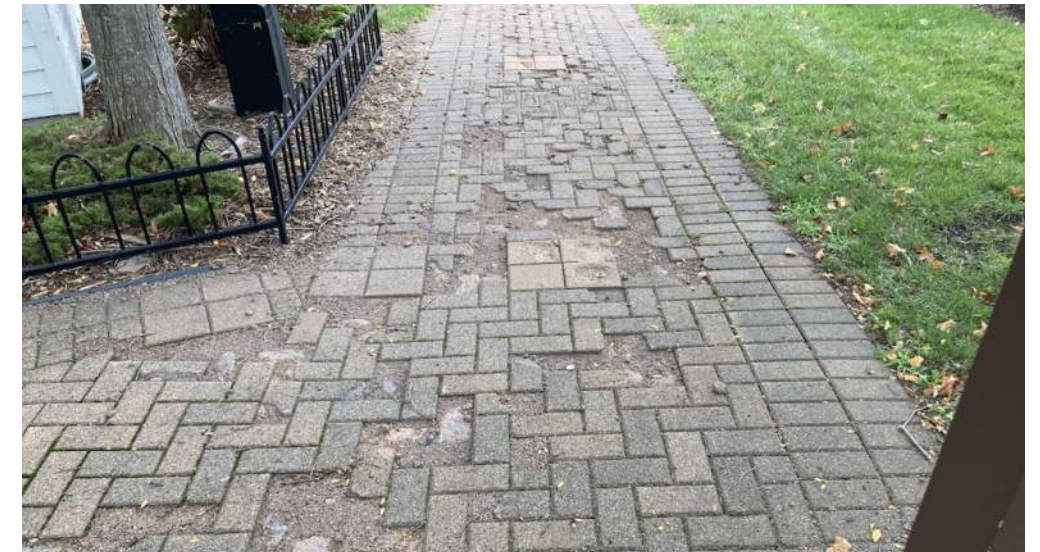
- » Replace windows
- » Exterior paint on building is starting to chip

- » Chimney is starting to deteriorate
- » Bell tower damaged

- » Many missing bricks in the walkway, repair these areas. (May need to regrade some areas)
- » Trim trees at building
